MAXIMUM REACH ENTERPRISES

DESIGN OF JACKING POCKETS & A 1,600 TON JACKING SYSTEM FOR LEVELING A RECIRCULATION BIN

VERDE GOLD MINE, CHILE

Leveling of the recirculation ore bin

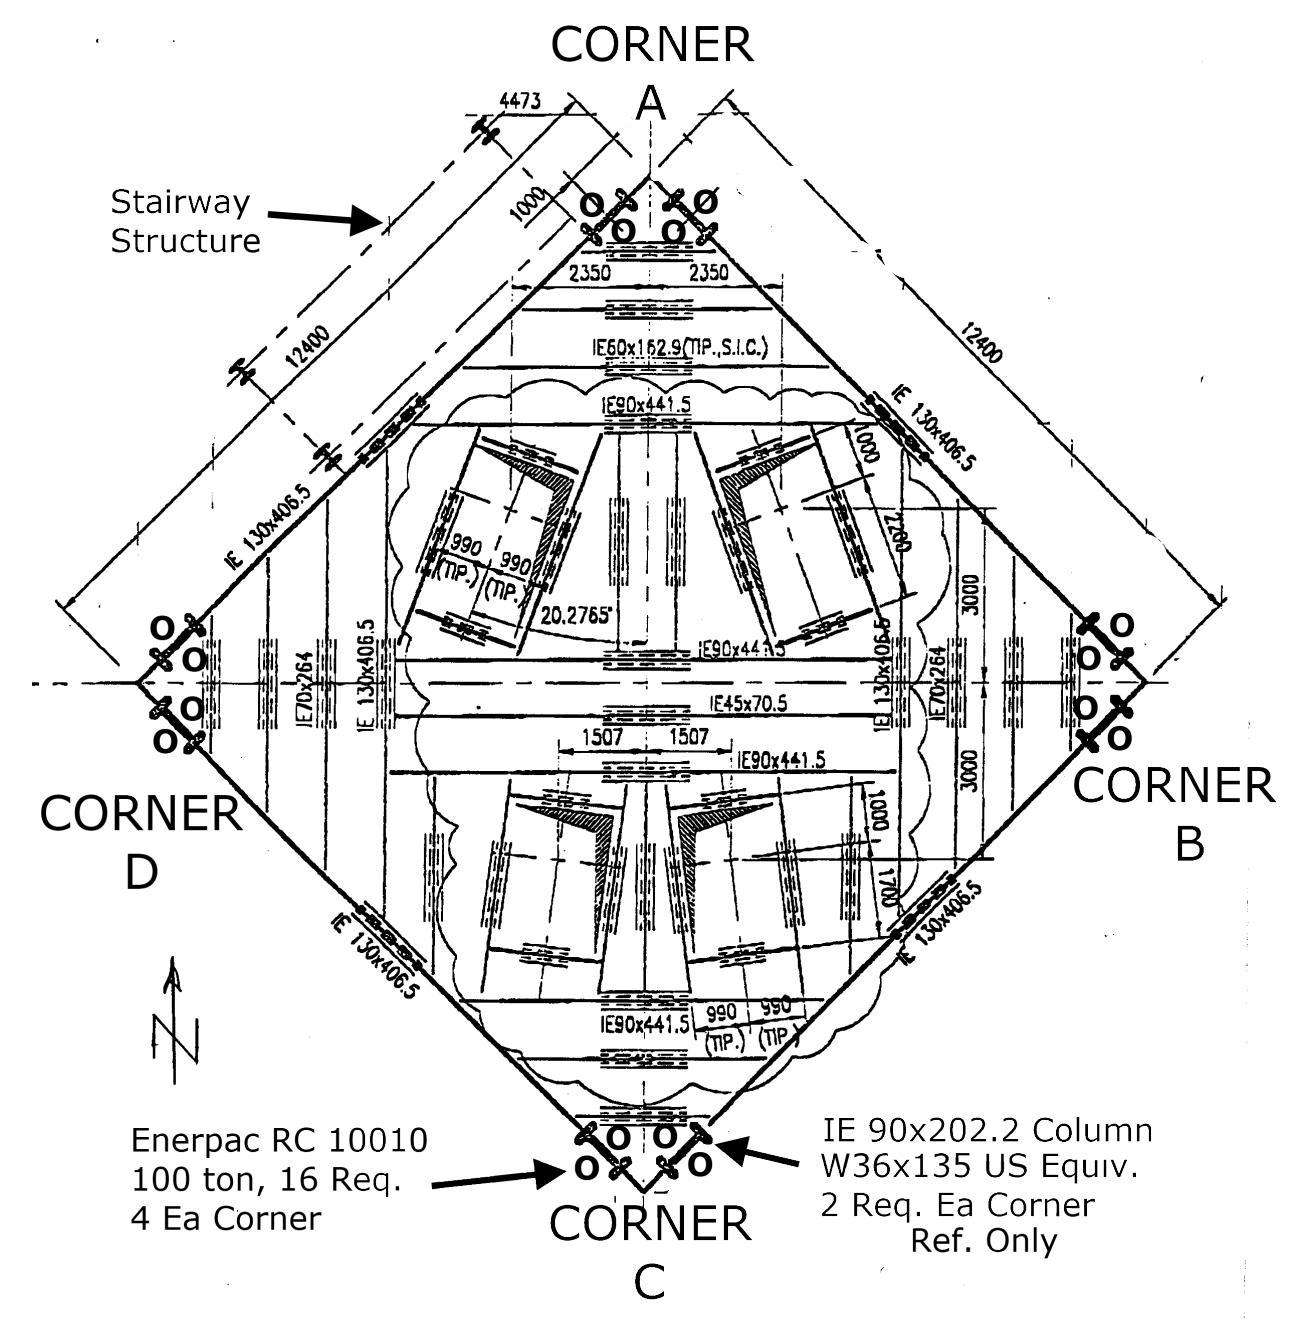
about 35' (10.7 m) over the bottom of the valley. See the plan view of the bin below. The drawings called for the original soil under corner A to be excavated down to the level of the soil under the other three corners and then the whole area to be back filled in 6" (150 mm) lifts. This was not done and the crew merely started down in the valley and back filled the area up to the elevation of the concrete foundation. To compound matters, witness said that as it was winter when the back fill operation was going on, the crew used 3' (0.9 m) lifts and included ice and trash in the backfill material. So when the bin foundation was poured, corner A was setting on original soil while the other three corners were setting on approximately 35' of fill. The original CM had received his bonus, quit the company after the mine was turned over to the owner and before settlement had started to occur.

The mine owner realized something was wrong when the top of the recirculation bin rotated out from under the large return conveyor that feed oversized ore into it,

resulting in large pieces of ore being scattered over the whole area. At the time we were called, corner A had settled 3'' (76 mm) and corner C had settled 12'' (305 mm). The new CM's crew on site was busy injecting grout under the bin foundation to stop the settlement.

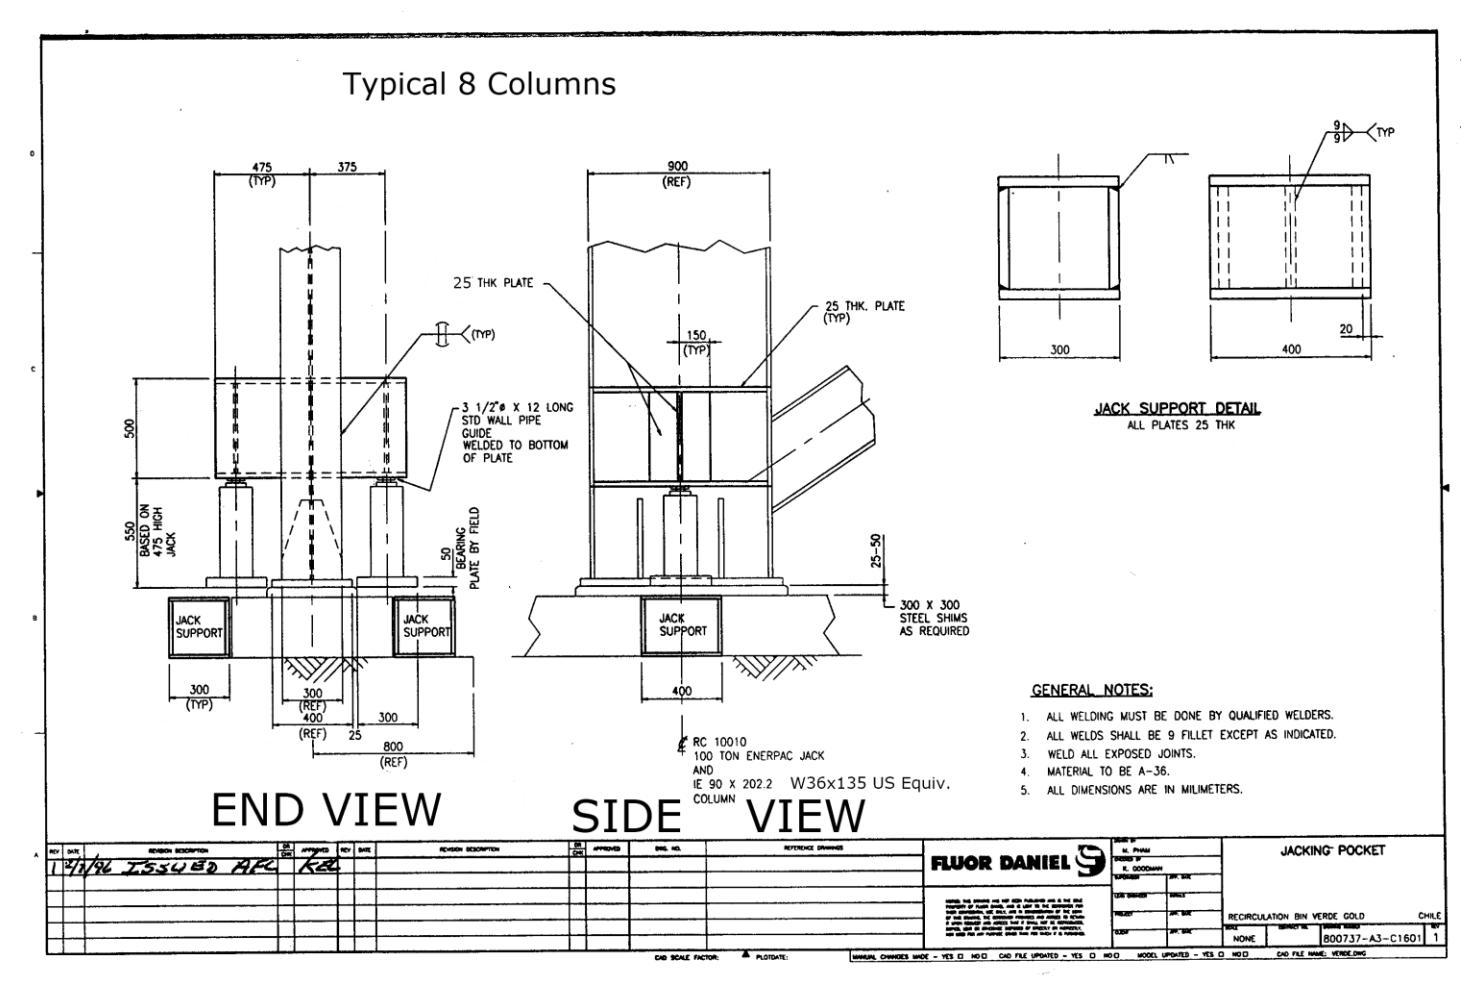
Note that the W36x135 columns sat on a 300 mm high x 800 mm wide grade beam so jack support boxes had to be design to provide support under the cylinders. Note that a 50 mm base plate was used under each cylinder with steel shims as required between it and the support boxes. The jack support boxes rested on the bin foundation.

The design of the recirculation bin was basically made up of four frames, one on each side, with two W36x135 wide flange columns at each corner. To prevent bending in the columns, I decided to weld a jacking pocket to both sides of each column. Each jacking pocket was designed for a 100 ton load. Now, unlike the jacking pocket design that I sent out showing how to size the vertical gusset plates to prevent buckling when used on a saddle, I decided to design the two jacking point on one side of the column to centerline of jacking point on the other side. See the end view in the jacking pocket drawing. This way, only a beam section would be required that was strong enough to prevent over stressing the beam in bending & shear due to the 200 ton design load at the center, and enough weld length to weld it all together.

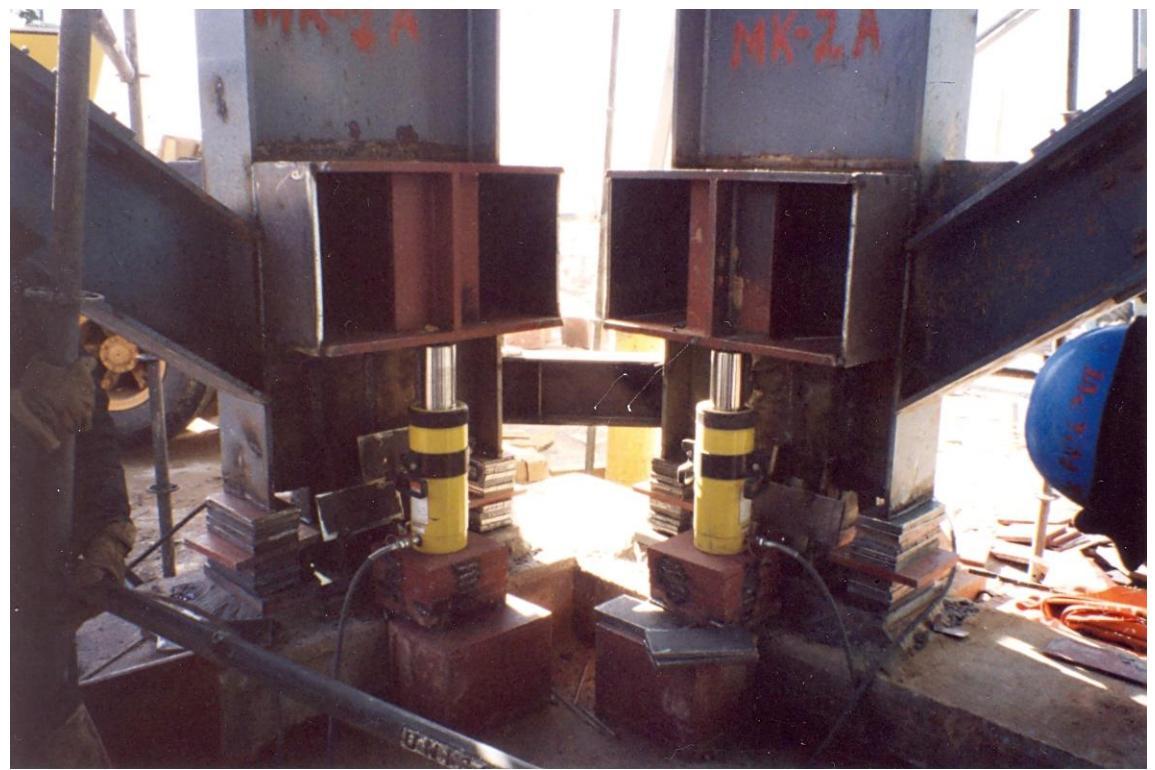
Looking At Corner C From The Inside

Note the large amount of shims under the two cylinders and also at both corners of each column. The cylinders at both corners C & D had to be retracted and shims placed under them to raise the bin back up to its original level.

When the bin was at the designated elevation, all gussets were welded to the column webs. The stub columns were only half width, ie, only a flange and half the web, so that the safety shims on one corner of a column could be removed and the stub column could be slid into place between the gussets and welded. Then the safety shims on the other corner were removed and the other half of the stub column was slid into place and welded. This made the installation and welding of the stub columns very safe and efficient.
