MAXIMUM REACH ENTERPRISES

SAFETY IN THE DESIGN AND THE EXECUTION OF RIGGING OPERATIONS

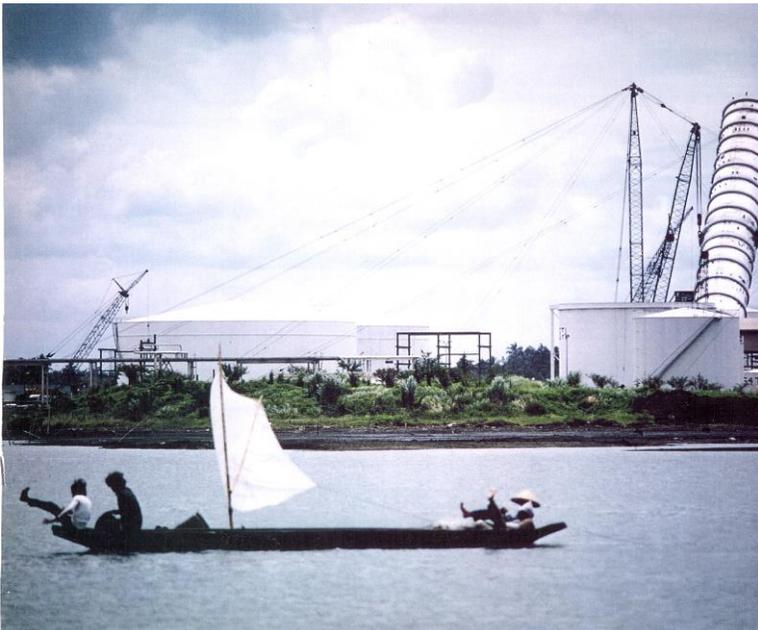
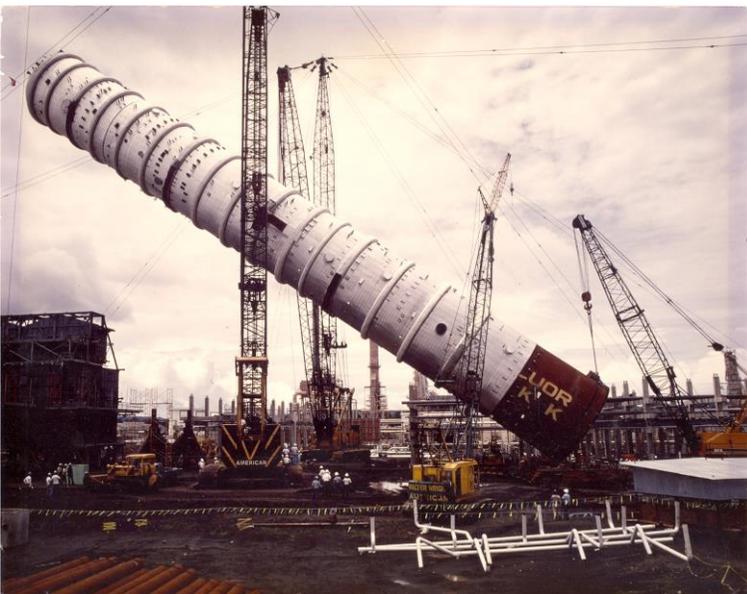
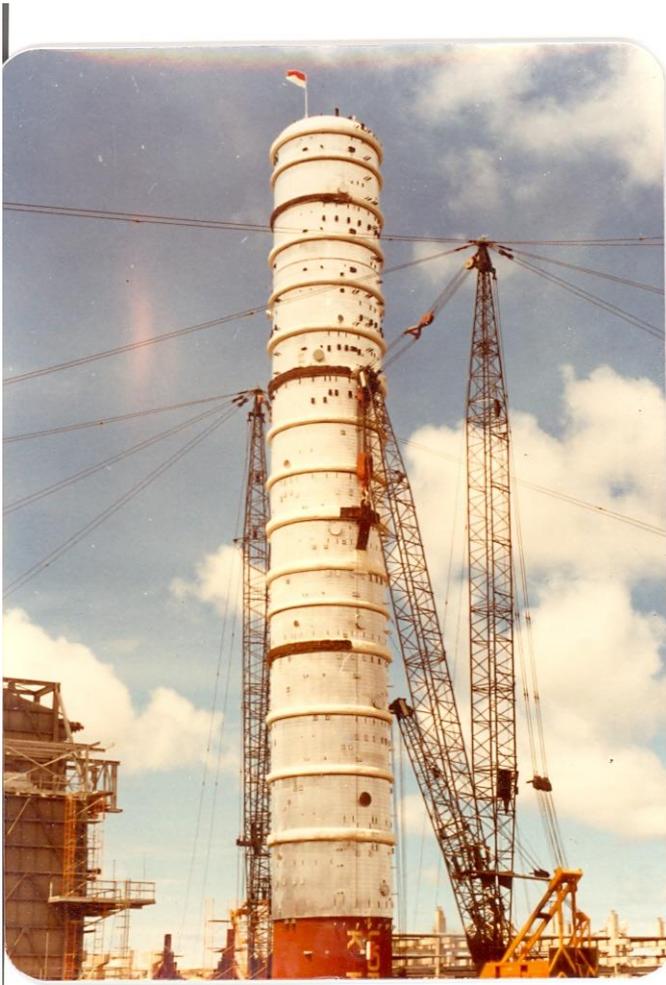
Three Photos Of The Crude Column Lift:

I want to share with you what was one of the high lights of my rigging career. The three photos below show the erecting of a crude column 32 ft. in ϕ x 285 ft. high x 1,169 tons. I supervised the design of this lift in Irvine, went to the field and helped convert the American 11320 lift cranes into the guy derrick configuration, helped set up the guy derricks and guy wires, operated the guy derrick in the foreground in setting the crude column (see second photo), and then helped reconfigure the cranes back into lift cranes. Each guy derrick had a capacity of 600 tons.

Notice in the second photo above that there are a lot of people shown in and around the crude column lift where they shouldn't be. This is because we had a main drum failure on the guy derrick in the back ground and the crude column was held in this position in the air for three days. The drawing below shows the details of the lagging for the main drum. AH&D used lagging around the drum shafts so that the crane owner had the option of using different diameters of hoist line, ie, 1.25" for crane work or 1.38" for dragline work, etc. The flanges of the lagging were bolted to the flanges of the drum with 28 high strength bolts. Note the 1" space between the two halves of the lagging. The failure occurred because the high tension in the hoist line caused the lagging to deflect until the two halves touched in the middle and took the shape of an hour glass. This caused the flanges on the lagging to pull away from the flanges on the drum until the top bolts in each end of each half broke. We tied off the hoist line in two places, removed the rest of the hoist line from the drum, replaced all of the 28 bolts, welded a 1" flat bar in the gap on each side of the two halves of the lagging, cut the hoist line so that there would be five wraps on the lagging and then reinstalled it. We then did the same to the other guy derrick. Then we completed the lift.

The cause of this near miss was a design failure on the part of AH&D. They designed the lagging based on the drum being about half full when the full load was seen by it. But with erection of the crude column, the side lifting lugs were located about 5' above the center of gravity. This meant that each crane and main drum was seeing about 575 tons at initial pick. To make the lift work, we started the lift with 5 wraps of hoist line on each drum. Therefore, the lagging didn't have 6 layers of wire rope to distribute out the load, so the two halves of the lagging pulled together like an hour glass as explained above.

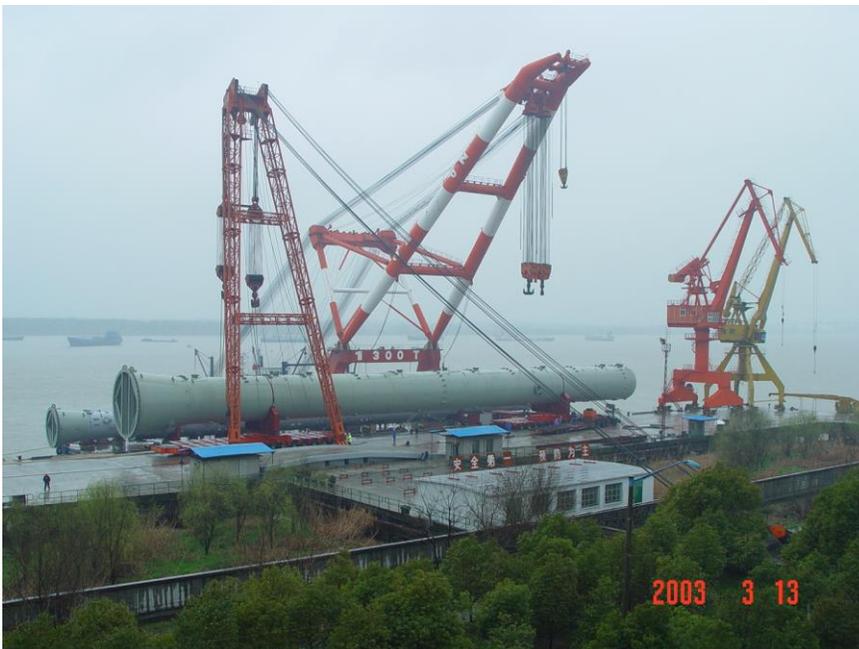
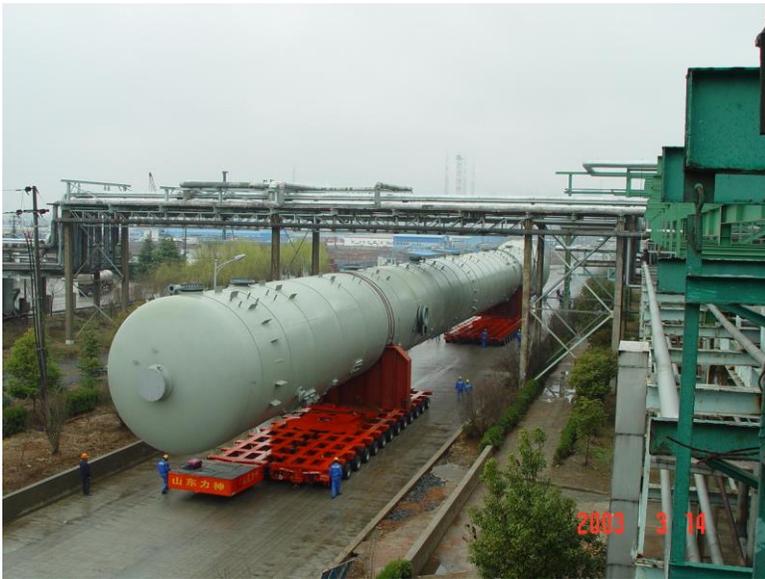
The first two photos below show the offloading and transportation of the rectifier.

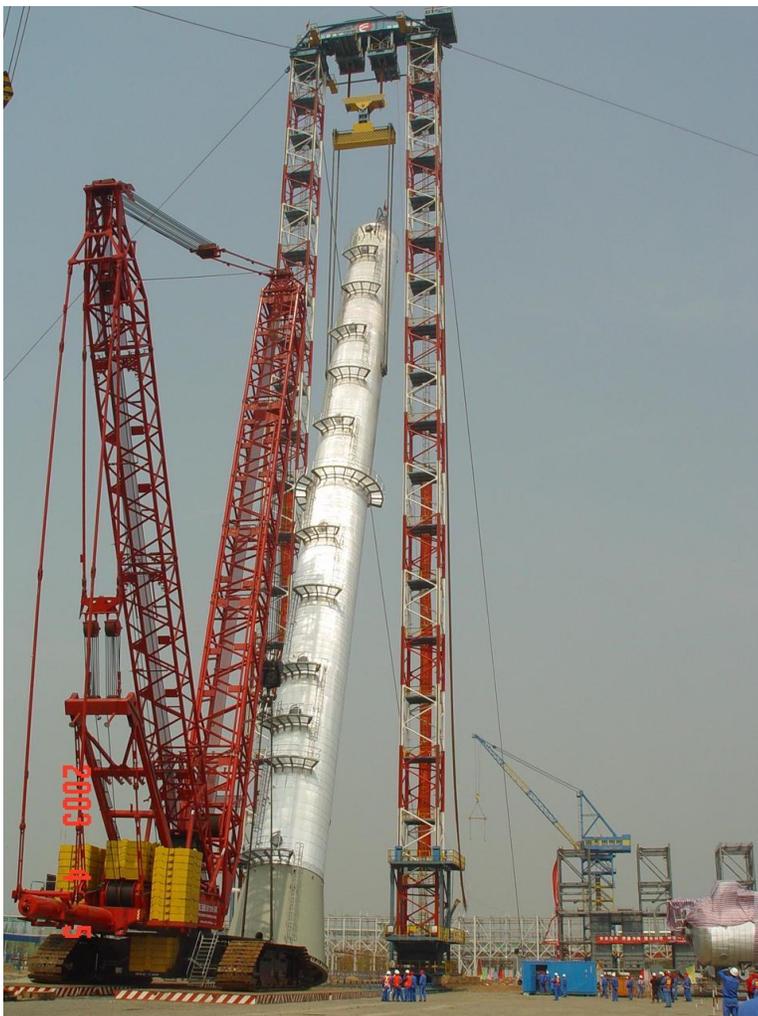
The next photo shows the dressed out rectifier being upended.

In my report, I stated that lifting the vessel with the trunnions as they were would not cause a failure but would cause serious buckling of the shell in the area of the trunnions but as they would be covered up by the insulation and cladding, the buckling would not show or be discovered until a crew went into the vessel to adjust the trays. They would then find that the tray beams and trays would be buckled, as well the shell around the trunnions. This would be hard to repair with the vessel in the set position.

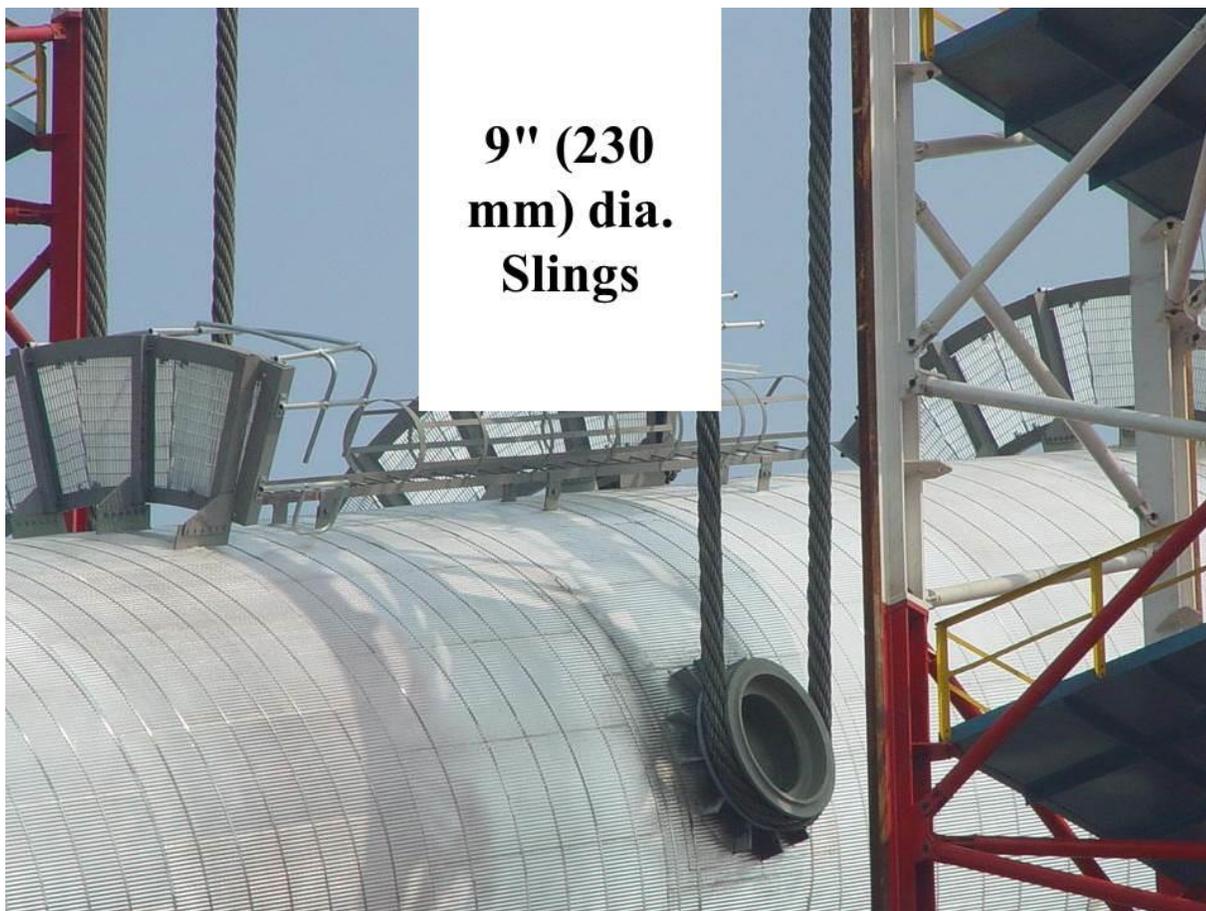
The fourth photo shows the right trunnion with the radial gussets which were part of the modification. The rest of the modification is covered up by the insulation and cladding.

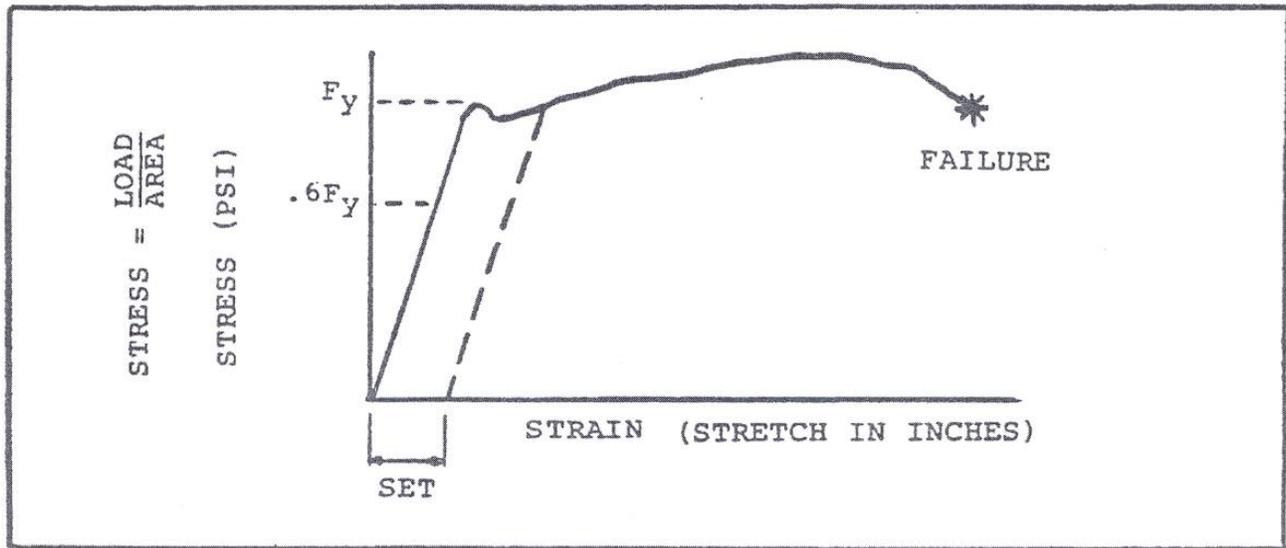
Note that F_y means Yield Stress & $0.6F_y$ is the allowable yield stress for steel design. Also note that actual stress = Load/Area. The graph shows that if we do not exceed the yield point of say a link, that it will return to its normal length when the load is released. But if the load is increased until the link is stressed beyond the yield point, then set occurs and the link will not return to its original shape. If the link is stressed further, then the link will fail.

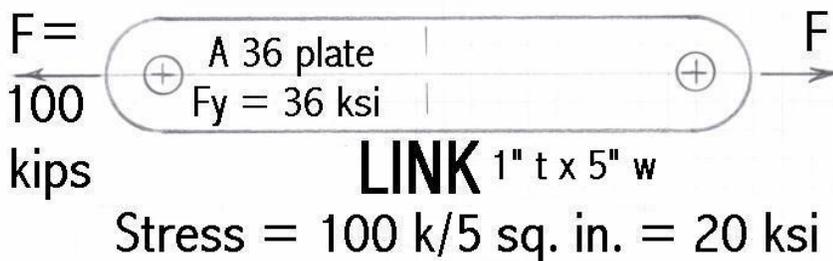
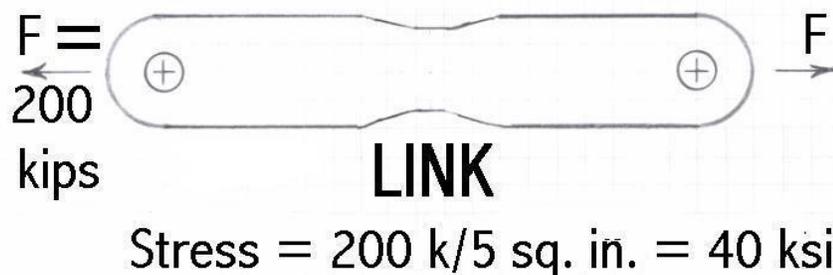
For example, in the sketch below, the link is 1" thick x 5" wide and is being pulled by a 100 kip force and the stress is $100/5 = 20$ ksi. For A36 steel, $F_y = 36$ and $0.6 \cdot F_y = 21.6$ ksi. Therefore, the link will not be overstressed and will return to its original length. But, if we increase the force to 200 kips, then the stress becomes $200/5 = 40$ ksi and the link will have permanent SET in it and won't return to its original length.

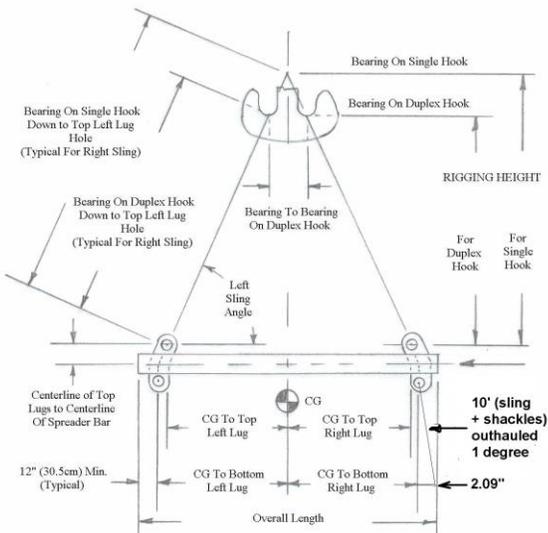
SPREADER BAR WITH LUGS TOP AND BOTTOM

The engineering departments goes too great lengths to make sure that spreader bars are designed for a certain load. The overall spreader length which corresponds to the center to center distance between lifting lugs on the vessel and the inclined sling lengths are listed on the rigging drawing so that the angle of the slings produce the required capacity in the bar. But, sometimes the length of the spreader bar actually used in the field is shorter or longer than the length listed on the rigging drawing. When this happens, the bottom slings are out of plumb toward the center of the bar (in hauled) or out of plumb away from the center of the bar (out hauled). If the bottom slings are in hauled by say 1 degree, the capacity of the spreader bar will increase by approximately 10 % because the bar is being bowed up in the center and this moment will reduce the downward moment. On the other hand, if the slings are out hauled by 1 degree, then the capacity of the spreader bar is reduced by approximately 10 %. If the distance from the bottom lug hole on the bar down to the lifting lug hole is 10', then the horizontal distance for 1 degree is 2.09". This means that the spreader bar cannot be more than 4" longer than the center-to-center distance between lifting lugs in order to keep the reduction below 10 %. So, make every effort to size the inclined slings and the spreader bars for the length listed on the rigging drawing. .

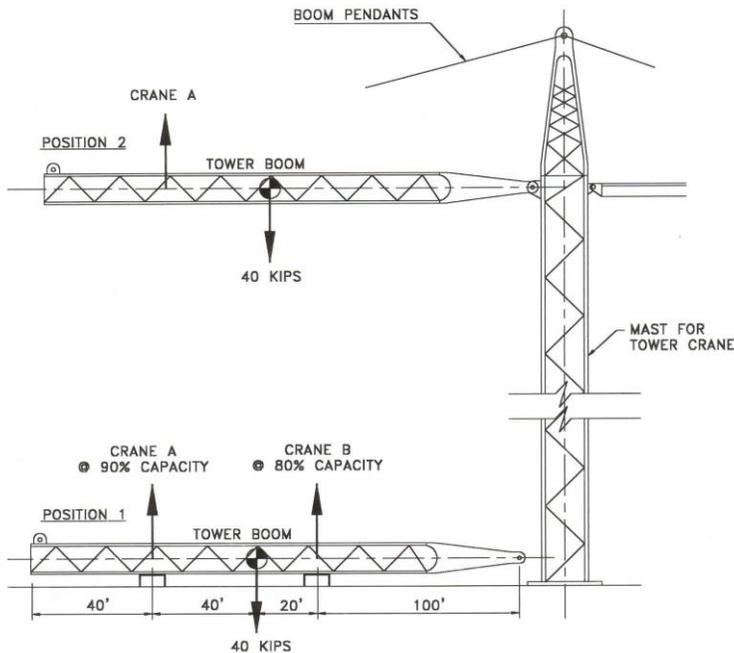
Any operation that includes the transfer of a load in the air should be studied very carefully. If not, an accident can occur similar to the one shown in the sketch. This accident occurred on a project in Brazil and the sketch was made as a lesson learned. As the boom foot was pinned to the mast of the tower crane and crane B was slacked off, the load to crane A went from 14 kips to 30 kips which was about 125 % of the chart and it started to turn over. To save the crane, the operator dropped the hammerhead boom where it was severely damaged when the tip hit the ground.

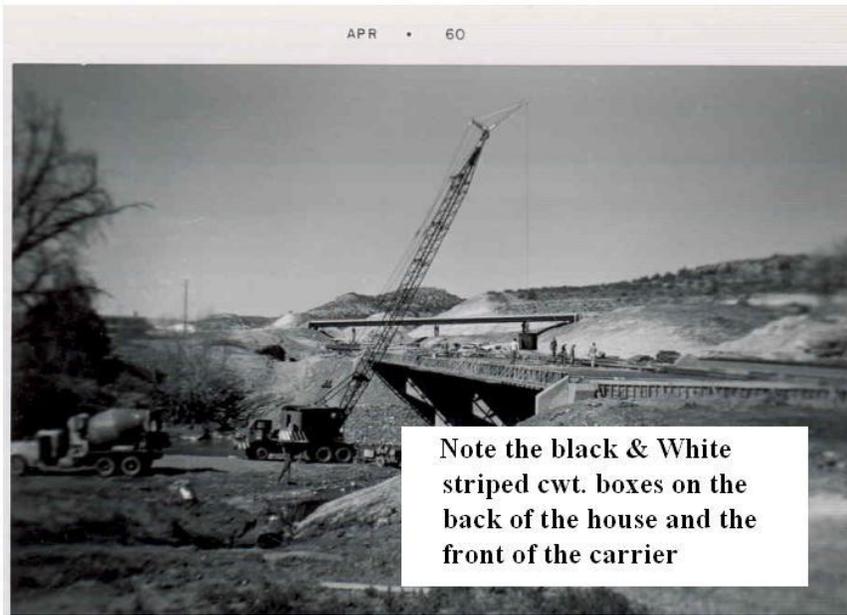
I oiled for an operator named Howard who was a very good operator. At least at the time I thought he was, but looking back on this experience with my current knowledge I can see that he was a very dangerous operator. I will tell you why. He was operating a 25-ton Northwest truck crane and decided that we need more lifting capacity. We didn't have a lifting capacity chart for the crane and just picked until we started tipping. Anyway, he had the master mechanic fabricate two counterweight boxes. We then welded one of them to the back of the house on the crane and the other one on the front of the carrier. We then went to a steel fabricator in Phoenix and got 10 tons of steel punches and put half in each counterweight box. This probably increased the capacity of the crane somewhere between 30 and 35 ton. Mind you, this crane only had one front hook roller and two back hook rollers. At this point, the crane was so back heavy that we could not swing over the side without outriggers for fear of turning over backwards. But boy could we lift. We poured with a 3/4 CY concrete bucket and we could lay the 110' boom down to about 60 degrees with a full bucket. The first photo below shows a counterweight box welded to the back of the house and one to the front of the carrier.

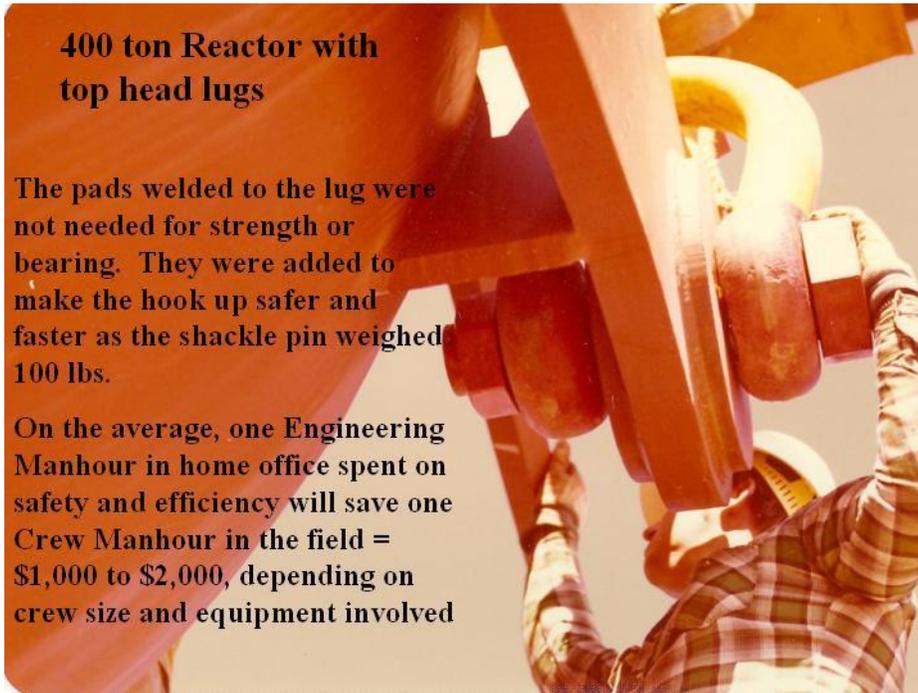
This photo shows pads welded to the top head lugs for a 400-ton reactor. These pads were not required for strength but were put there to act as plate spacers to center the shackles on the lugs. As heavy shackle pins can be hard to install thru loose plate spacers and can pinch fingers, we decided to weld the plate spacers to the lug plates to make the operation easier and safer. Note that in general, one-man hour spent in the engineering office can save one crew man-hour in the field. This could translate to a saving of \$1,000 to \$2,000, depending on the size of the crew and equipment being used.

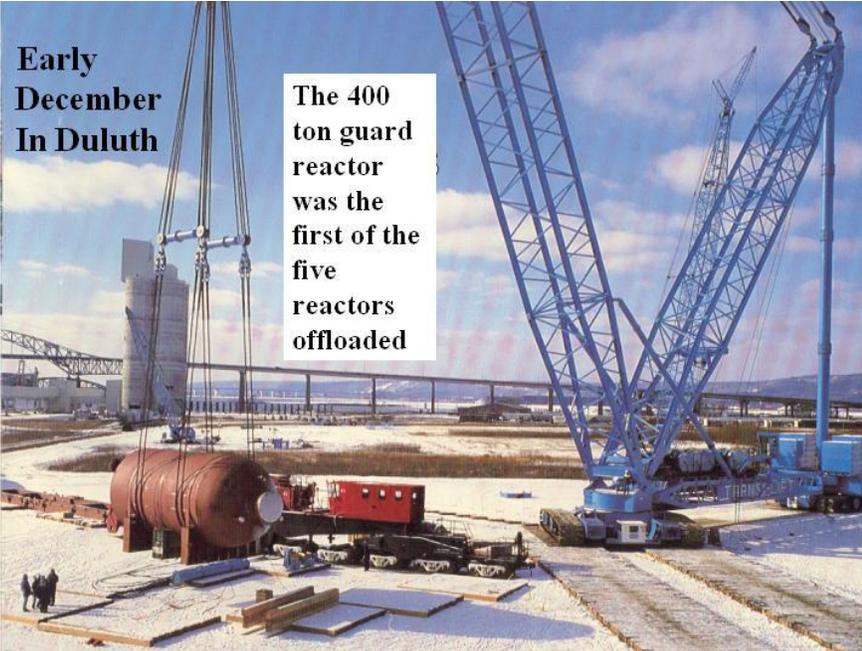
The second photo shows offloading the 400-ton guard reactor, which came in on the deck of the heavy lift ship. The other four reactors were stowed in the hold. Note the spreader bar configuration which was rented as a unit from Lampson. This was not a good set up as the spreader bars were labor intensive to assemble and adjust the length. The eight 2.5" dia. x 102' long slings were a nightmare to handle. We should have cut them into 50' lengths and used shackles to connect them under the bottom of the reactors.

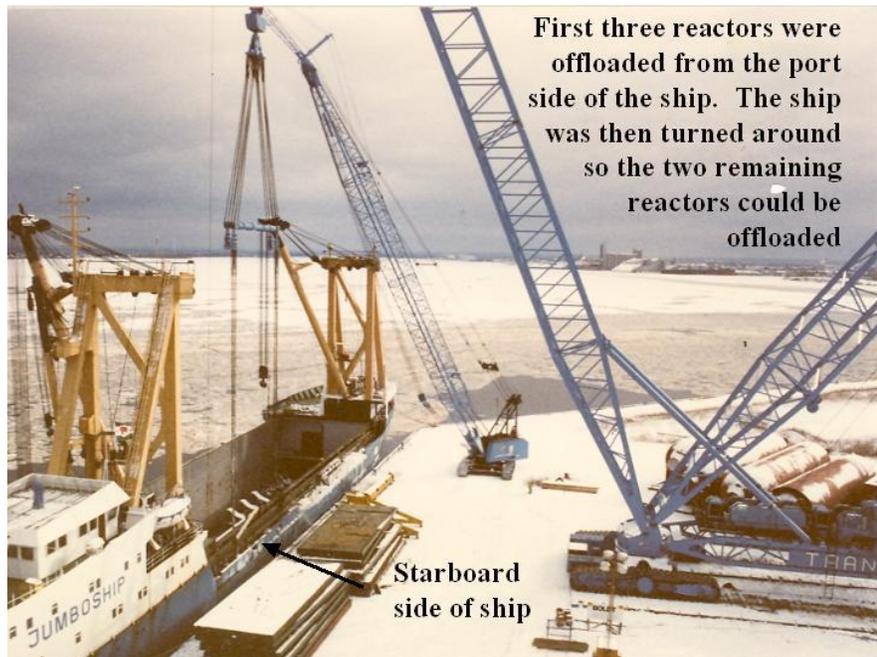
The fourth photo shows three of the reactors offloaded and staged and the ship turned around for offloading the remaining two reactors.

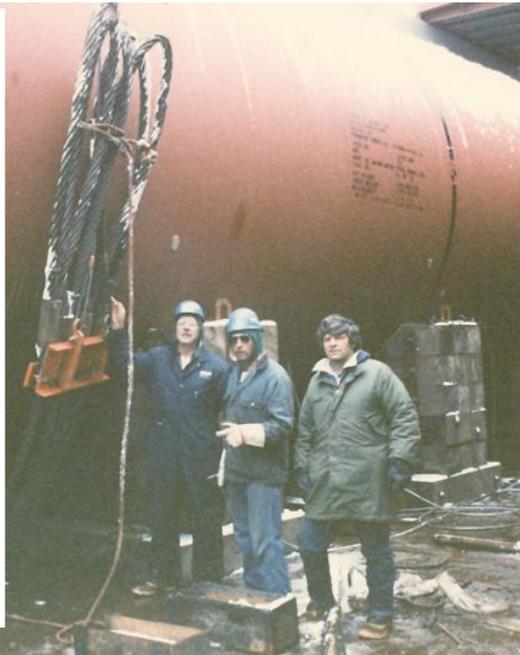
The fifth photo shows a special spreader bar clamped to four 2.5" dia. slings for pulling them under the reactor and on up to hooking them to the 85 ton shackles on the main spreader bar.

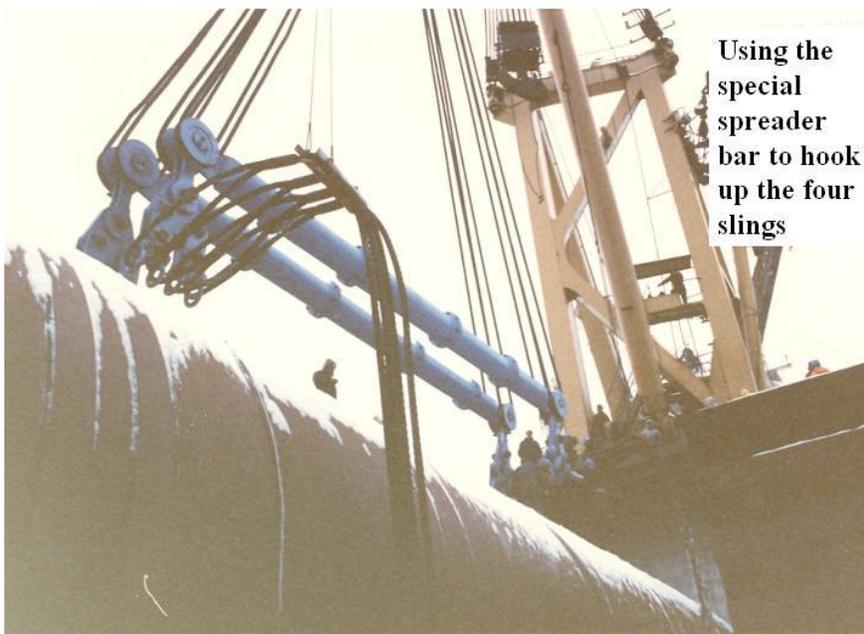
The next photo shows the eyes of the slings laying over for easy connecting to the shackles.

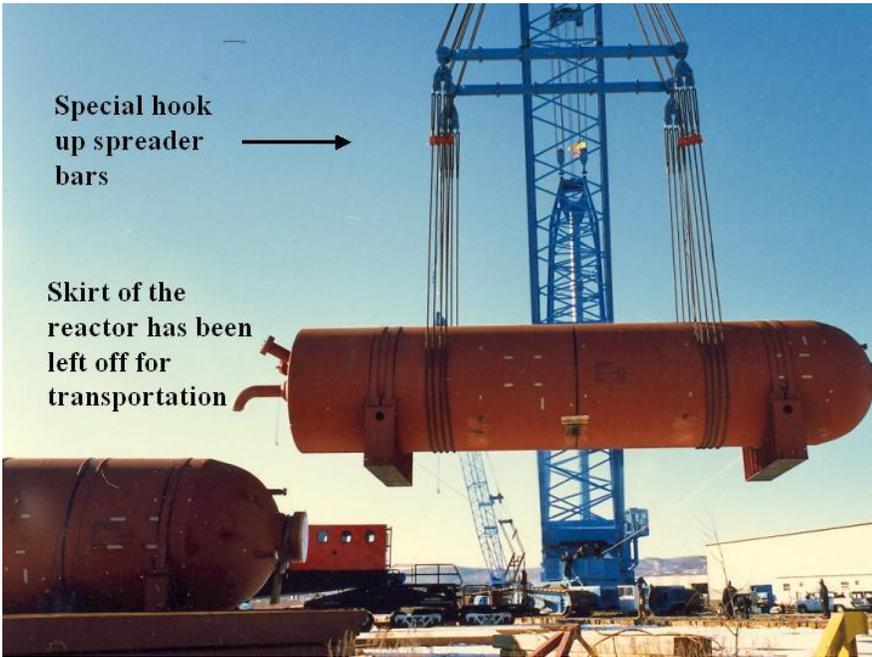
The seventh photo shows the fourth reactor being walked back away from the ship. Note that once the special spreader bars were clamped to the slings, they were left that way until the job was finished.

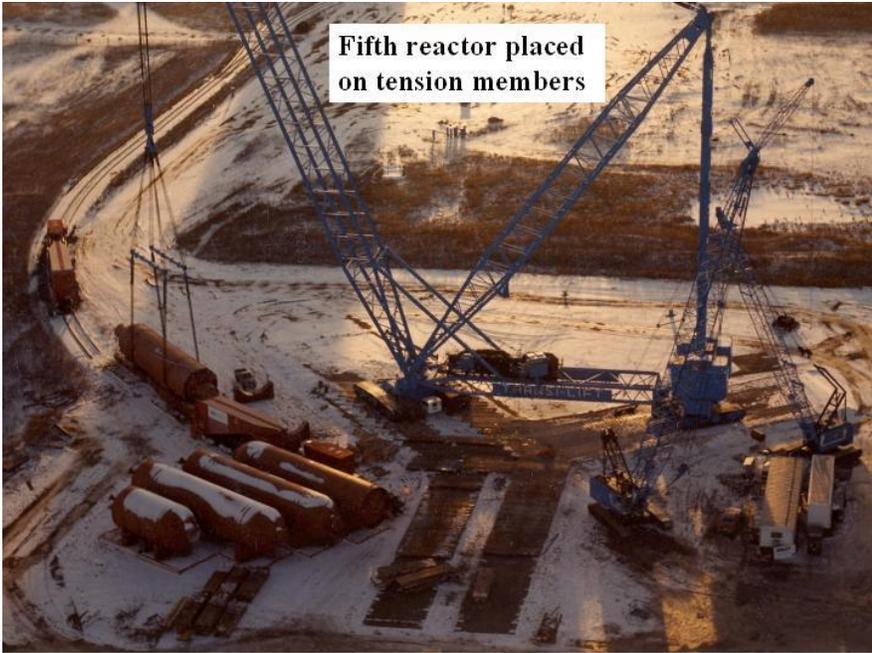
The eighth photo shows four of the reactors staged and the last one placed on the tension members.

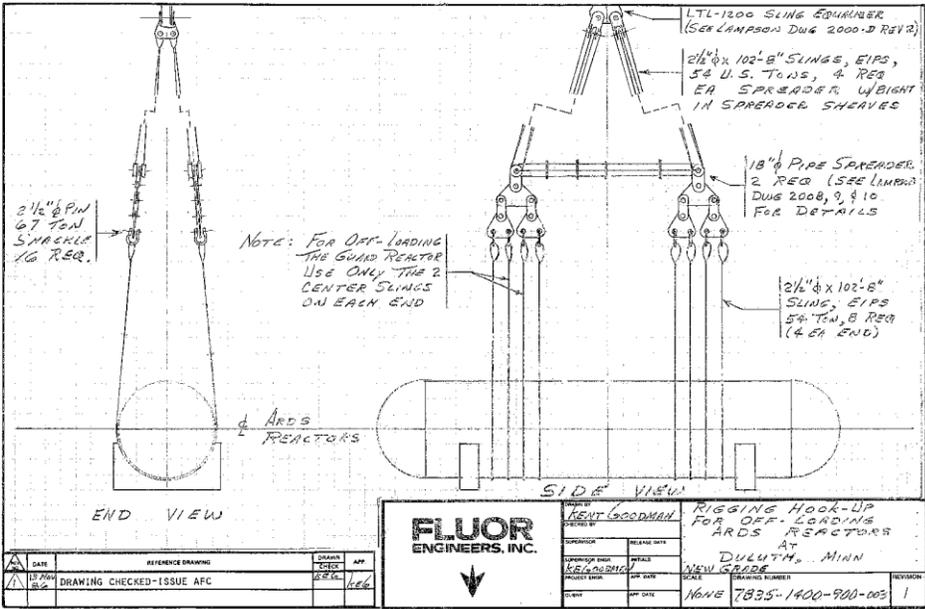
The last photo shows the details of the rigging hook up. In the next section, this rigging hook up will be compared to the one used at Regina for offloading the reactors from the Schnabel car.

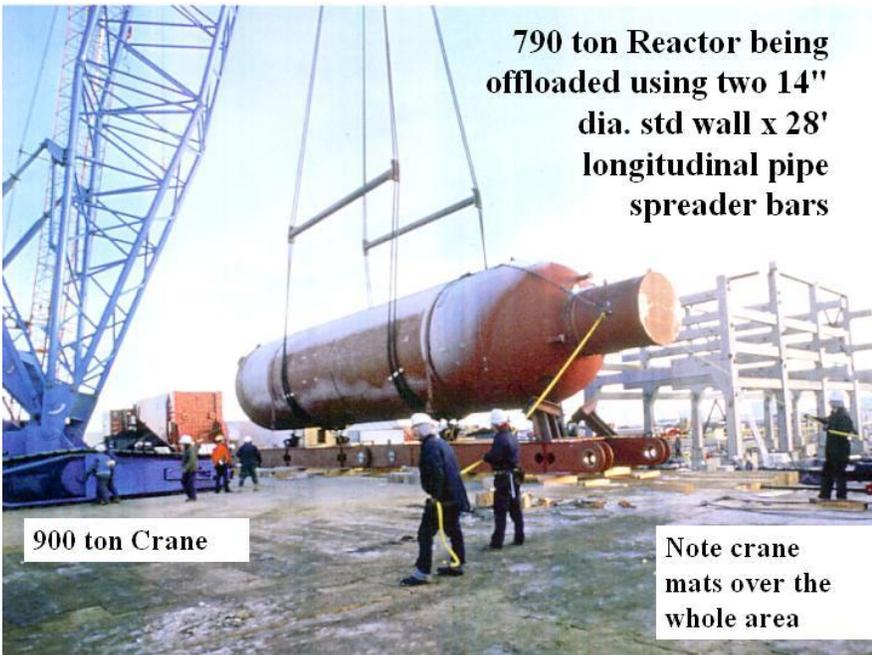
The five reactors were then transported to the jobsite at Regina, Saskatchewan, Canada. The first photo shows a 790-ton reactor being offloaded from the Schnabel car using two 14" dia, Std. wall, x 28' long longitudinal spreader bars. Note the simplicity of the design compared to the spreader bars that were used in Duluth. The eight 3.5" dia. slings were connected under the reactors with four 120-ton shackles. We could have purchased two complete sets of bars and slings for the rental we paid for the one set in Duluth.

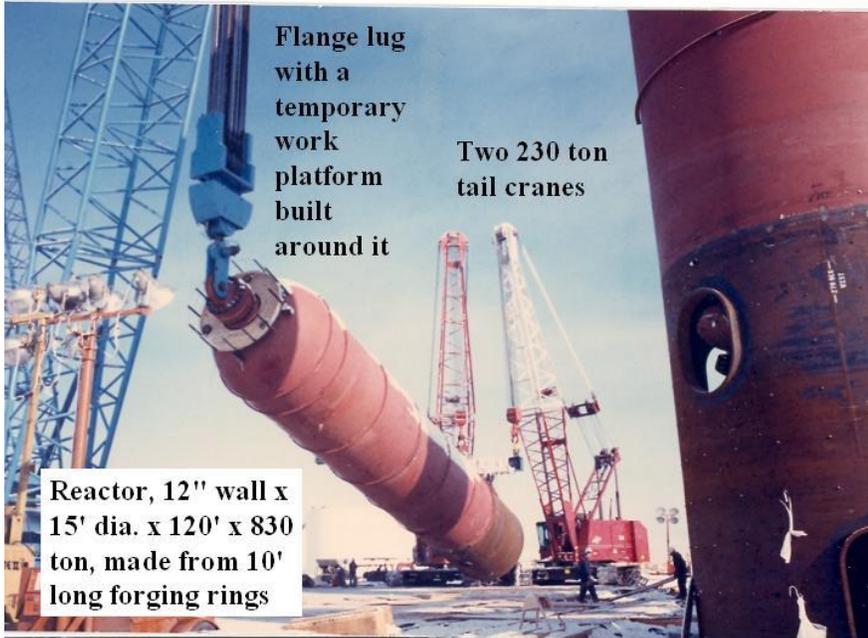
The next photo shows the temporary work platform that we designed for 200 psf so the boilermakers could stage themselves and all of their tools including a power pack and hydraulic wrench for removing the four-inch dia. nuts holding the flange lug on. The temporary work platform was held in place by bolting it to the brackets for the permanent platform.

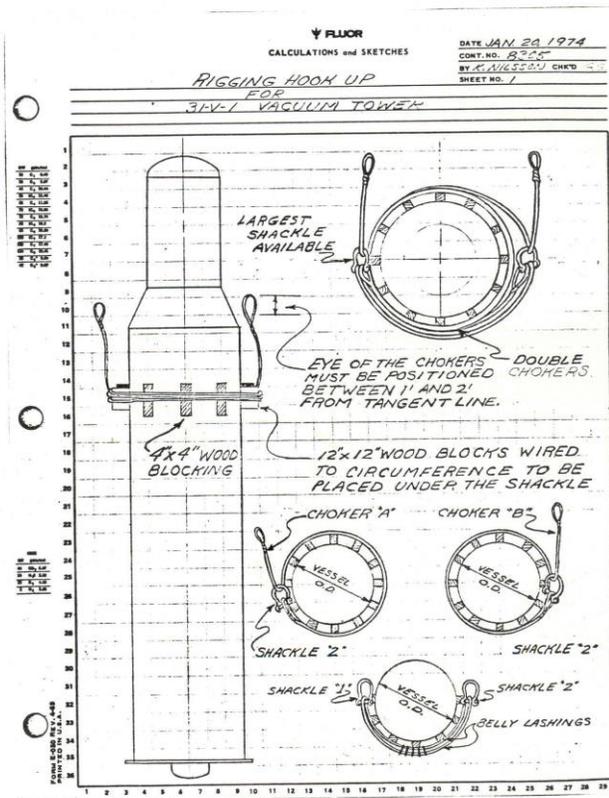
FLUOR RIGGING ENGINEERING MANUAL	CHOKER & TWO CRANES	NUMBER 4.6.8
		PAGE 3
		DATE 2/27/76

Many years ago, the Fluor rigging department developed a method for erecting vessels that didn't have lifting lugs attached. This included lifting the top off of tall vertical vessels that had become corroded so bad that lifting lugs could not be welded to them. This method was called the double choke method. The first photo shows a drawing on how to lift a vessel by wrapping doubled slings around it. As you can imagine, this was a very labor-intensive operation and the slings didn't always stay where they were supposed to.

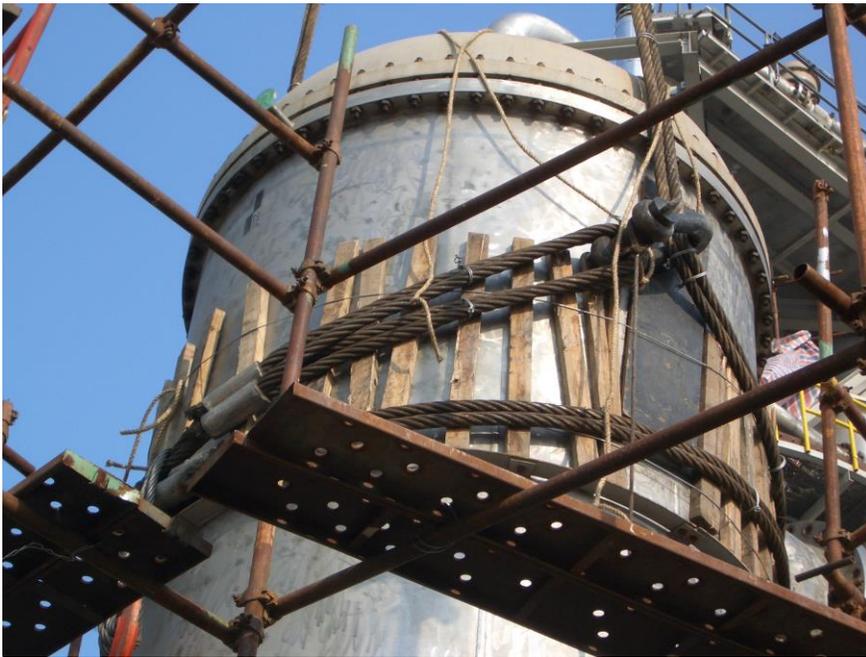
The next photo shows a lift in China (made by another company) where the slings have slipped up almost off the wood lagging during the lift. You can see how hard it is to keep the lift shackles level with one another using this method. But if they are not keep level, then the tension will not be the same in each lift sling.

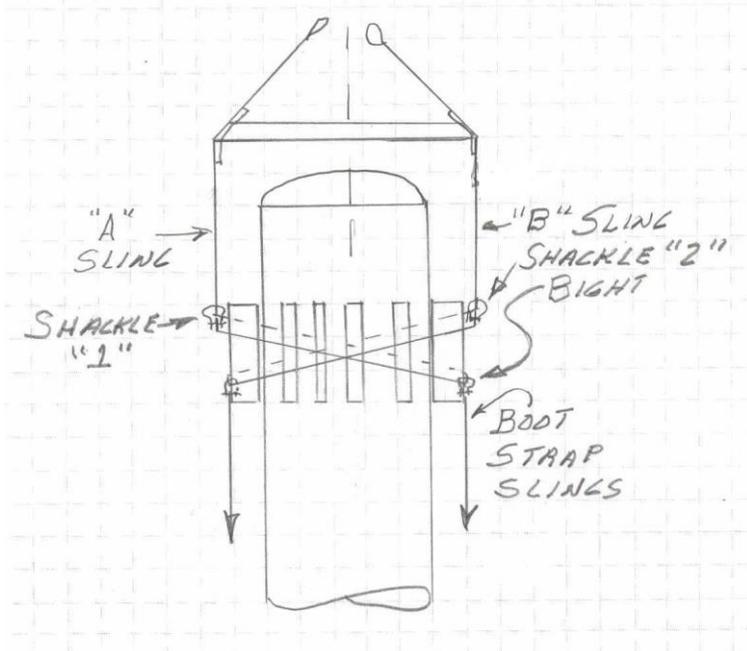
The next photo shows how the bootstrap slings were hooked.

As soon as we had the Skyhorse assembled at Mt. Vernon, we removed the large piping from the vessel and then put our rigging on the hook. It was made up of a spreader bar and two 2.75" dia. short slings. Longer 2.75" slings were connected to the short slings. We chose to double choke the vessel just above a 180-degree platform. We hung 6' long 4" x 4" dunnage from the top nozzle with rope & eye bolts to provide friction between the insulation and the slings. With four men working off the platform and three working out of a basket suspended from a crane, it took us six hours to rig it up. The above photo shows the Skyhorse hooked up to the vessel. As a safety measure when using the double choke method, I always connected boot strap slings with a shackle at the bight of the double choke slings and hooked them down to nozzles or lugs at the base of the vessel. This time was no different as we shackled the bootstraps down to lugs that we had welded to the basering. The bootstraps were not intended to carry a lot of load, just to keep the bight of the double choke slings from moving up and thus keeping the shackles level.

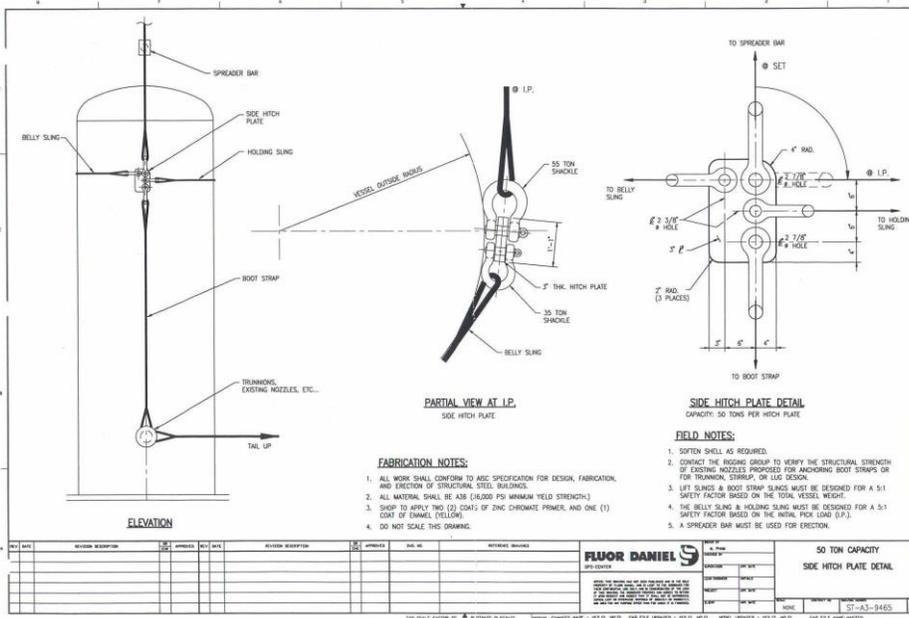
As I was flying back to Las Vegas, I said to myself, "there has to be a better way than using the double choke method", as it was so labor intensive and dangerous. So, I started making some sketches and by the time we landed, I had a pretty good idea for a method that I felt would replace the double choke method. Later, I finished the design and then called it the Side Hitch Plate Method. The next photo shows the details of this method.

To use it, all you have to do is to hang all of the rigging on the hook, swing the rigging into place around the vessel, have someone hook up the holding sling from a platform or out of a basket (sort of like a woman putting on a bra), hook up the boot strap slings to lugs at the base and then lift the vessel. We have used this method many times and it works real well. Shurtleff and Andrews used it to remove the top section of several vessels at the Chevron refinery in Salt Lake City, but Brad Shurtleff could not find his photos. So, I apologize for the condition of the next four photos. The first photo shows the top section of a vessel being lifted off the bottom section by the side hitch plates.

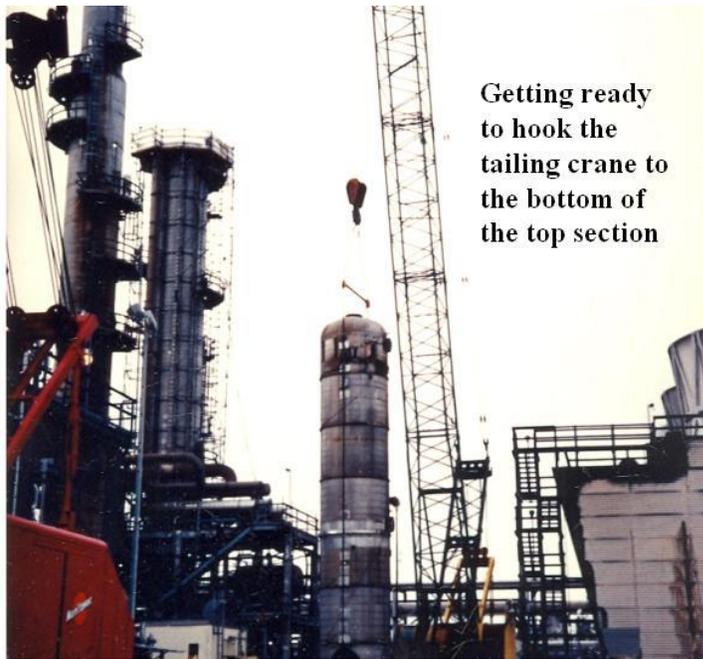
The next photo shows the top section down on the ground.

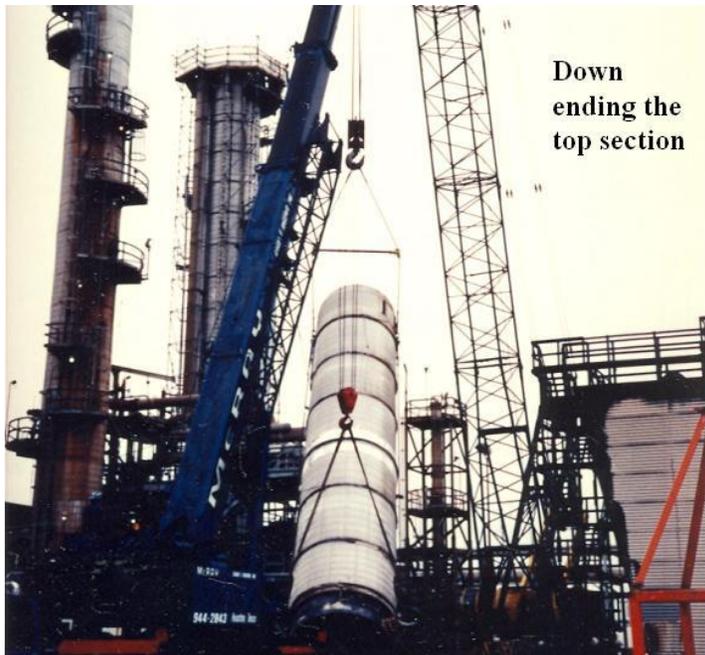
The next photo shows the tail crane being hooked up.

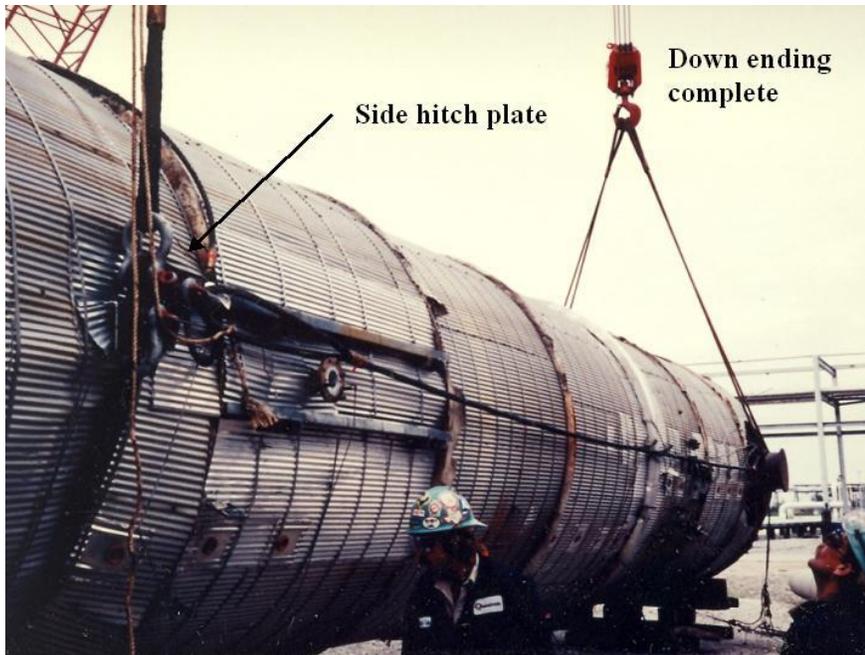
The last one shows the top section horizontal. It is not real clear, but you can see the various components of the side hitch plates in the last photo.

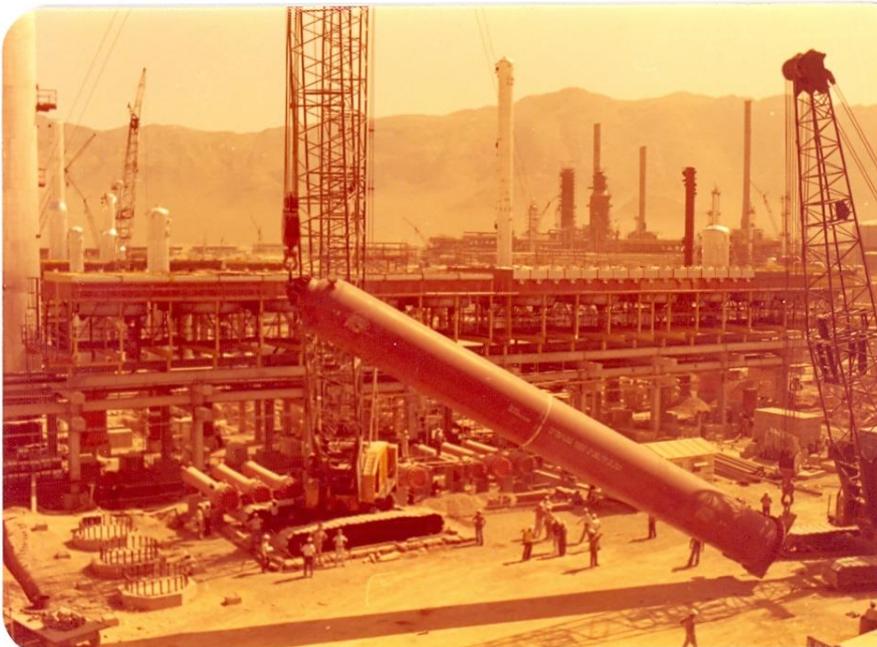
One of the lifts was setting three 275-ton reactors from one set up. The first photo shows a reactor being upended and the three foundations directly in front of the Guy Derrick.

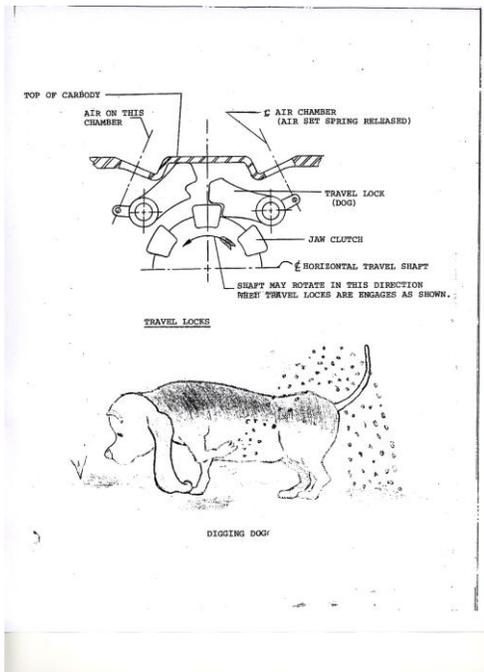
In getting ready for this lift, the division of labor was Dennis and I was to place the deadmen, layout and tension the guy lines. Lennie and his two Expat crane operators were to construct the lift pad, lay the crane mats on it and then position and block the crane per the drawing. There was a note in the set up section of the drawing that said "Position the crane at the planned radius, set the travel locks and back up against them". The second photo shows a sketch of the travel locks. Some old timers call travel locks "digging dogs" because cranes were used a lot for dragline work and the locks kept the cranes from being pulled into the hole they were excavating. AH&D were very adamant that their travel locks were not

digging dogs, hence the cartoon at the bottom of the sketch. My thanks to Ron Kohner for providing this sketch.

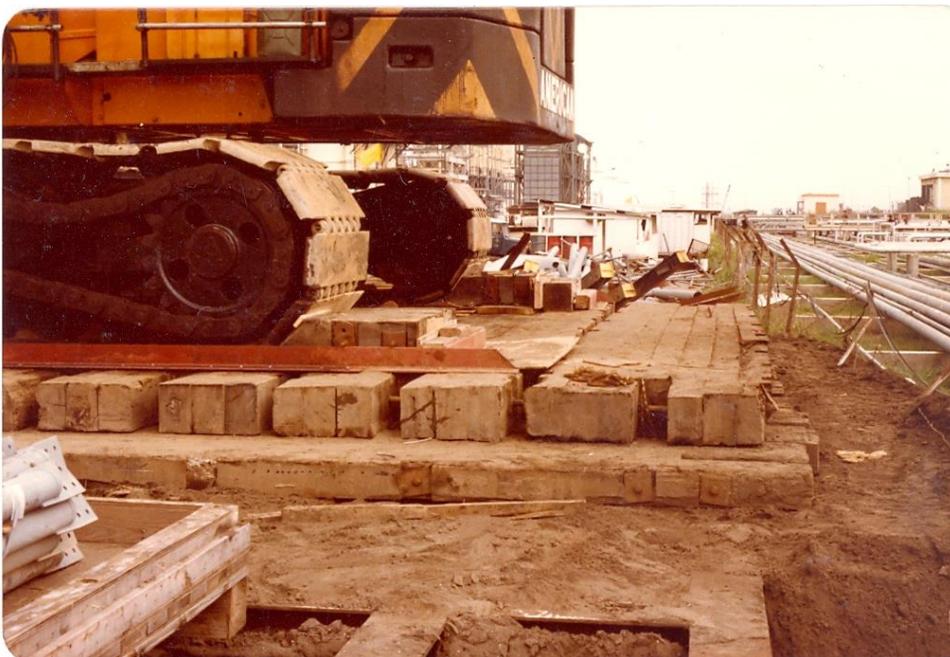
The third photo shows chocks and rails from another lift similar to the ones that should have been installed on this lift.

isn't going anywhere". I told him that I had calculated the sliding force from the boom and compared it to the resisting force between the tracks and mats and that we only had about a 1.25 safety factor. I also told him that AH&D recommended that the chocks and rails be used. Later that day, I went thru the lift pad area and the crane was still not blocked. Again I talked to Lennie but he was still firm in his belief that all was well. In the afternoon of the next day before we were to lift, I again went to Lennie and strongly recommended that we use the blocking. Again he said he didn't believe it was necessary. I then went to the office and talked to both the Construction Manager and the General Superintendent and told them of my concern. We talked about it for a while and then they basically said that Lennie had many years of experience, that he was in charge, that they trusted him and inferred that I was just a lowly Rigging Engineer with only one year of experience. I told them I was glad to have the chance to go on record in talking to them and voicing my concern in case any thing happened. That statement didn't set to well with them and I got long stares as I left their office. I decided that the next time I was put in this position, I would ask the CM for a letter directing me to go ahead and make the lift even though it wasn't being made according to the rigging drawings and that the CM would assume responsibility if any thing went wrong. Later, as I was training young rigging engineers, I instructed them to do the same.

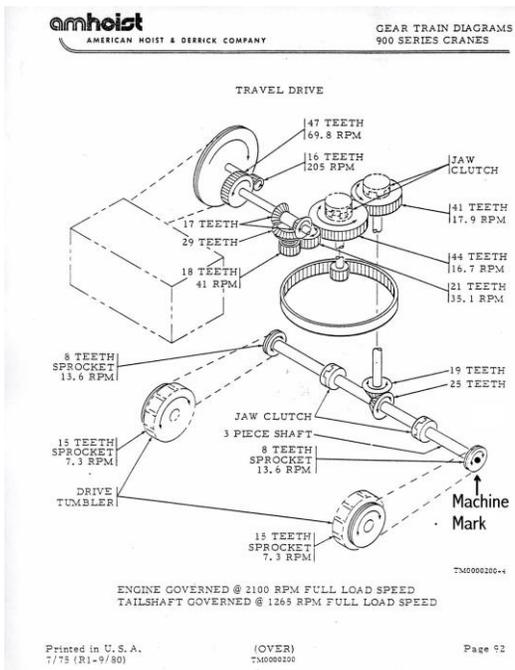
While they were doing this, the chief engineer came to me and told me that he felt that the crane had started rolling and then slid the rest of the way. He had a transit set up perpendicular to the car body and in monitoring the tip of the mast for plumbness, his reference point at grade was the machine mark in the center of the drive sprocket on the end of the travel shaft located in the center of the car body. But as the machine mark was occasionally in a shadow, he had his Rodman put a mark up on the edge of the track. He pointed out that the mark on the edge of the track was about 6" back from the center of the sprocket. Lennie asked the expat crane operator, who was operating the crane when it was being set up, if he had backed the crane up against the travel lock. He replied no, he didn't because no one had instructed him to. So much for following the notes on the drawing. If the crane had been backed up against the travel

locks, it probably would not have slid at all. See the next photo for the location of the machine mark on the drive sprocket.
