MAXIMUM REACH ENTERPRISES

SAFETY IN THE DESIGN AND THE EXECUTION OF RIGGING OPERATIONS

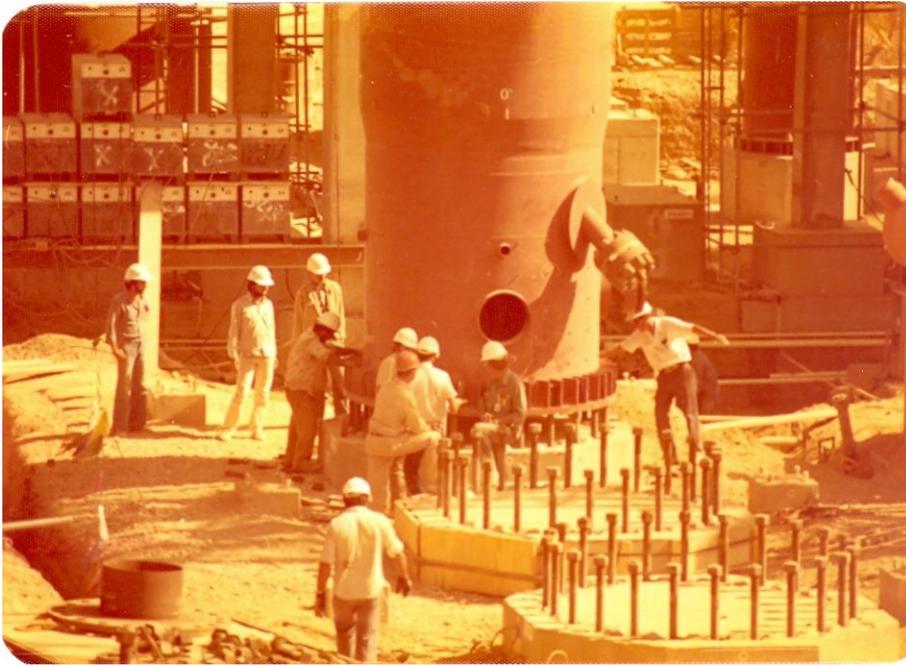
As Lennie and the riggers were lassoing and securing the crane, we positioned a transit behind the crane and checked the mast for deflection side ways. The maximum allowable side deflection was 6". The deflection was 12" so we tightened up on an opposing guy line and pulled the mast back inside of tolerance. We then raised the reactor until it was clearing the anchor bolts by a good foot, swung it about 2 degrees, moved the transit and checked the side deflection and again pulled the mast back in tolerance. We continued to do this until we were over the far foundation. We then lowered the reactor down over the anchor bolts. See the last photo that shows the reactor being lowered down over the anchor bolts on the far foundation.

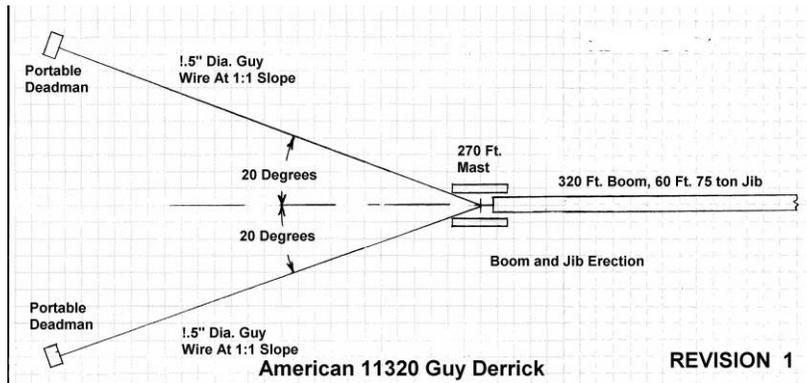
erection of a 300' freestanding flare stack. The rigging engineering department initially completed a crane study for this lift and found that a 320' boom and a 60' x 75 ton jib would be required. The plan was to walk the last guy derrick being used out of the unit over to the boom-changing yard. There the 250' boom was to be laid on the ground and extended to 320' plus adding the 60' jib. As this combination of boom was not self erectable by the guy derrick, we proposed burying two deadmen in back of the guy derrick, running a single guy line from the 270' mast down to each deadman, snugging up on the guy lines and booming the boom up into the air. The first photo shows our proposed method, which we sent to the field as Rev 1 about 6 weeks before lift date.

So, we dusted off the original drawing marked Rev 1, changed the boom length to 340', changed it to Rev 5 and sent it to the field. The last photo shows Rev 5.

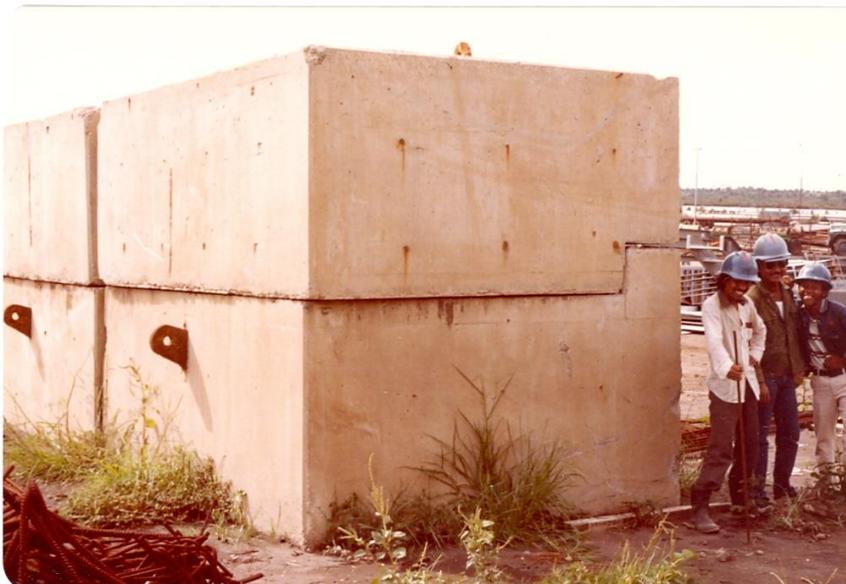
The next photo shows the standard portable deadmen that Fluor used.

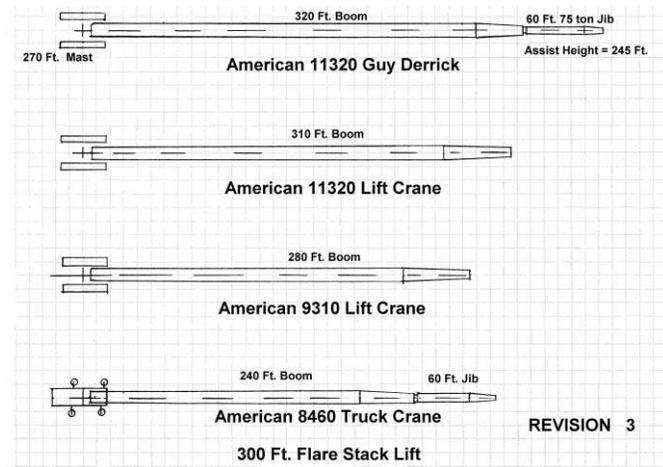
found that an Am 9310 lift crane with 280' of boom would be required to assist the 310' of Am 11320 boom up. A truck crane with a basket was also needed to cut the rigging loose for the Am 9310 lift crane and for the Am 11320 lift crane. The next photo shows the summary of the cranes involved with this scheme. The drawing was marked Rev 3 and was sent to the field.

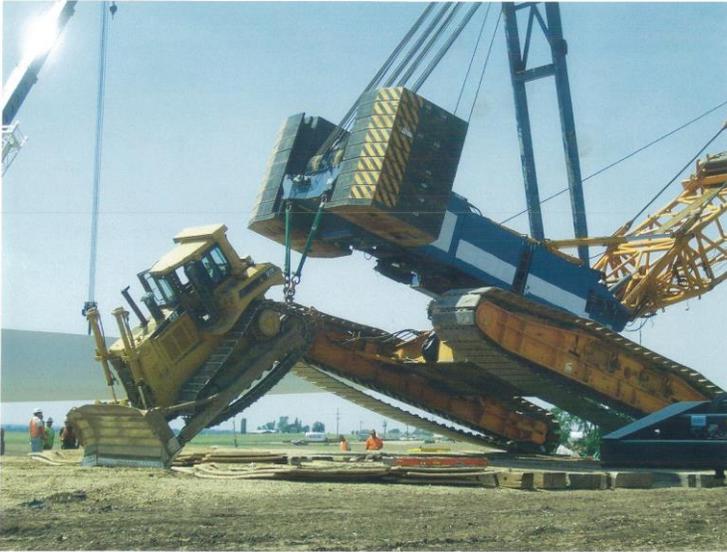
The first set included four photos, which were taken before the boom erection started. As we were very familiar with the American boom sections, it didn't take us long to discover that the boom was actually 340' long with a 60' jib. We then calculated that the assist height for this boom would be 295'. We also noticed that there was a Caterpillar D8 being used as a tie off cat. Slings were running down from the top of the A-frame to the drawbar on the cat. The slings looked tight. Have you guys seen a tie off cat being used? The next photo shows an example of a tie off counterweight.

1. The tie-off cat was just used as a safety precaution.
This was not true because to use a tie-off cat correctly, the slings must be left slightly loose so anyone can tell by looking at them if they are carrying any load. Then if they tighten up, you will know that they are preventing the crane from going over. In this case, if the slings had started out being slightly loose, but then tightened up when the assist crane was cut loose, the field would have known that the crane was trying to tip over and that they should assist the boom tip up higher.

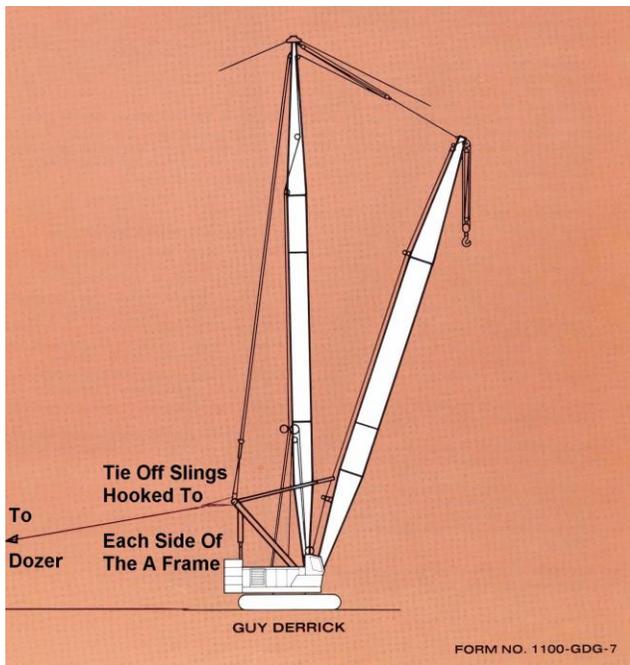
If it is felt that a tie off cat needs to be used, the next photo shows how to use it correctly. First, disregard the guy wire at the top of the mast as this was the best photo that I could find for this illustration. Next, the tie off slings should never be tight, unless the crane or guy derrick is starting to tip over.

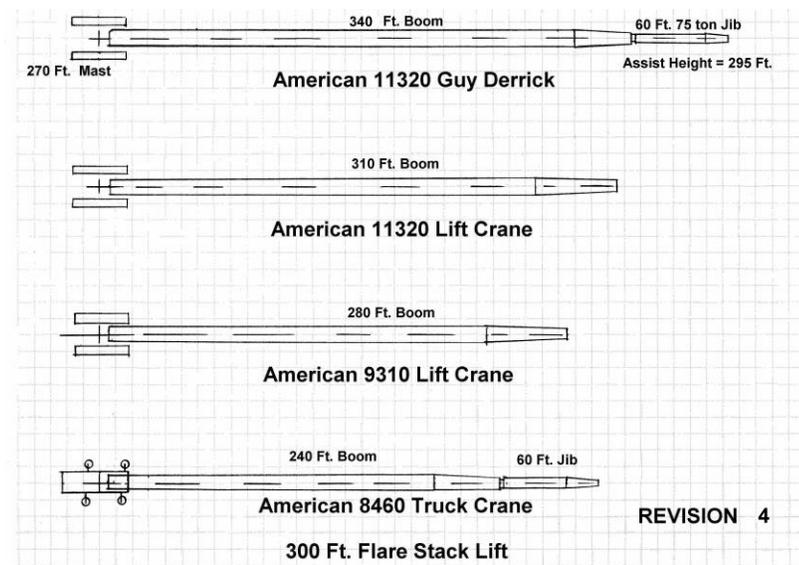
We wrote up our report, changed the drawing to Rev 4 which showed the guy derrick with 340' boom and the assist height of 295' and sent it to the field to show them that this was the drawing they should have been using when they tried to erect the guy derrick boom. The next photo shows the Rev 4 drawing.

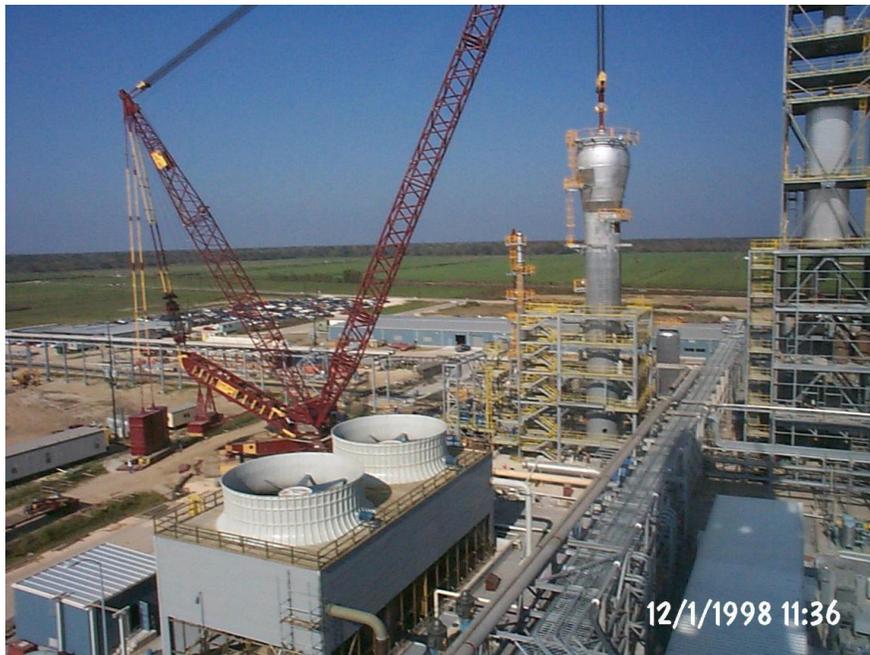
As you probably recall, Deep South Crane and Rigging was setting up one of their heavy lift cranes, a TC-36000, when they had an accident. They had erected the mast and boom and were in the process of hooking up the mast pendants to the auxiliary counterweight (Demag calls this counterweight the Super Lift) when the mast and boom came over backwards. See the next photo that shows the mast pendants hooked to the auxiliary counterweight on a Deep South Versa Crane. I don't think it is a TC-36000 and am using the photo just for reference.

The boom and mast fell on another crane and a personnel structure killing four workmen, two of whom were operating engineers. I read the accident report where it stated that the minimum boom radius was shown on the setup plans. It was not clear why the boom was set at a shorter radius. Here is a case that could also have benefited from hooking the load block to a tie off lug with the operator monitoring it.

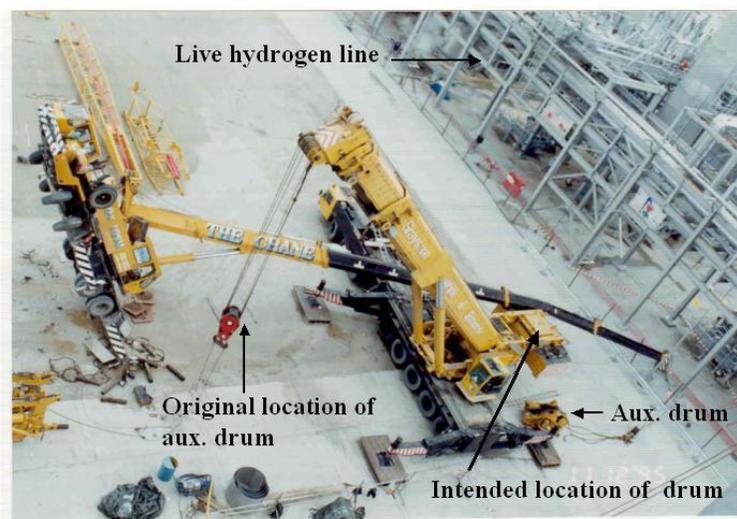
50 Te Crane turned over on 400 Te crane

In 1995, I got a call from the Construction Manager on a Fluor project in Thailand. The heavy lifts were completed and the project was about 75 % completed with several units on line. The reason for his call was to tell me about an accident that had just occurred where a 50 Te hydraulic crane was installing a luffing jib on a 400-ton truck crane. The 50 Te crane turned over next to a live unit and the boom missed hitting a live hydrogen line in a pipe rack by about 1'. The Photo below shows the accident and it will be discussed in greater detail later.

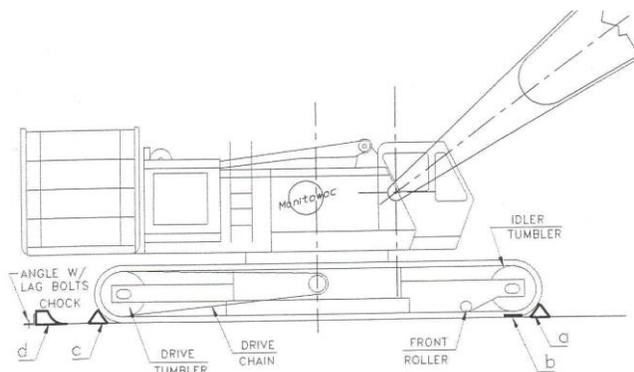
The first quiz, number 15 on my website, shows how to correctly block the front tumbler of a crane, not to get increased lifting capacity but to obtain the lifting capacity listed on the chart.

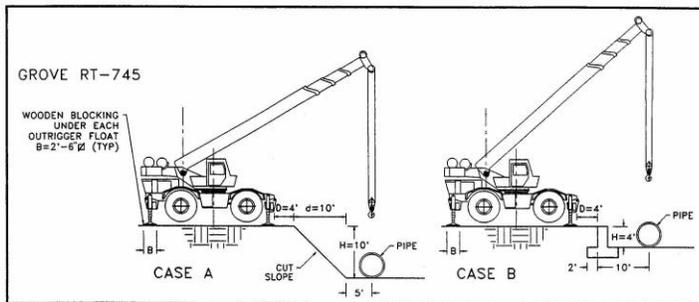
The third quiz, number 25 on my website, shows guidelines on how to determine where to set up a crane relative to a retaining wall or an excavation. I really like this quiz and spent some considerable time on formulating it because as was stated above, most crane accidents occur from tipping over or working out of chart or a combination.

1. Outrigger Float Diameter = 24".
2. Boom Is 81' Long.
3. Total Load (Load Block + Rigging + Pipe) = 14,000 lbs.
4. Soil Is A Sandy Loam With A Bearing Strength Of 3000 psf (pounds per sq. ft.).

1. Is the crane positioned far enough away from the shoulder of the excavation?
 Case A: Yes ___ No ___ if no, what should "D" be? ___ ft.
 Case B: Yes ___ No ___ if no, what should "D" be? ___ ft.
2. List five things to check for in regards to ground work prior to setting up a crane near a slope.
3. Is the outrigger blocking area "B" large enough?
 Case A: Yes ___ No ___
 Case B: Yes ___ No ___
4. In general, does the maximum outrigger loading occur at:
 A. Minimum radius with minimum boom & maximum load, or ___
 B. Extended radius with long boom & capacity load ___

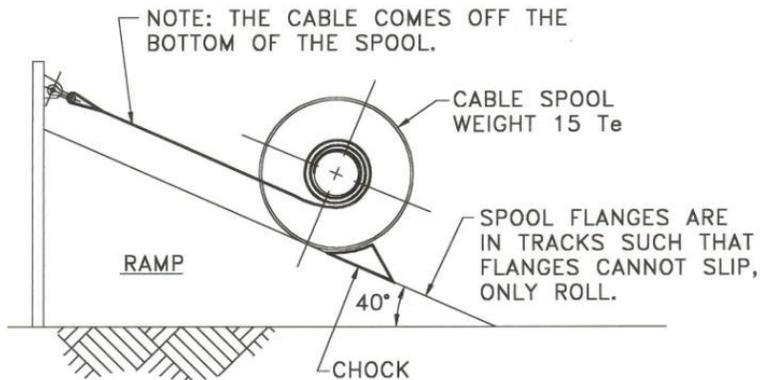
This photo shows a cable spool on a ramp with the cable tied off to a dead end. The question is asked will the cable spool roll when the chocks are removed? When I was in a static's lecture class of about 150 students at ASU, the professor had the Teaching Assistants (TA's) hand out this pop quiz to us. He told us that we had five minutes to look it and then just mark the box YES it will roll or the box NO it will not roll and then to pass them to the TA's at the center isle. The TA's pickup all of the pop quizzes, took them up to the podium where they and the professor started going thru them. When they finished, the professor looked up and called a student by name and asked him why he had marked the NO box. The student said he marked it no because he figured there wouldn't even be a quiz if it would roll. Another student gave another off the wall answer and then the professor called my name and asked me why I had marked the NO box. I told him that I knew that it would not roll but that I didn't know why. He asked kind of haughtily why I knew it wouldn't roll. I told him that many times I had rolled cable off a reel on to a hard road surface, and noticed that as the cable was unrolling, the dead end was slowly following along behind. If someone stood on the dead end, the flanges of the reel had to be slipped to continue unrolling the cable. The professor wanted an engineering answer but I couldn't give him one, so he gave me an E for effort. I like this quiz because it shows that things are not always as they seem. The next photo shows the engineering answer to the quiz.

To prove to your self that the spool will not roll, place a reel of cable, a spool of electrical wire, or a yo-yo on a flat surface and start to slowly unwind it. Note that as the spool is unwinding, the end of the cable/string is slowly following along behind the spool. If someone stands on the end of the cable, the flanges on the spool have to be slipped in order to continue unwinding the cable.

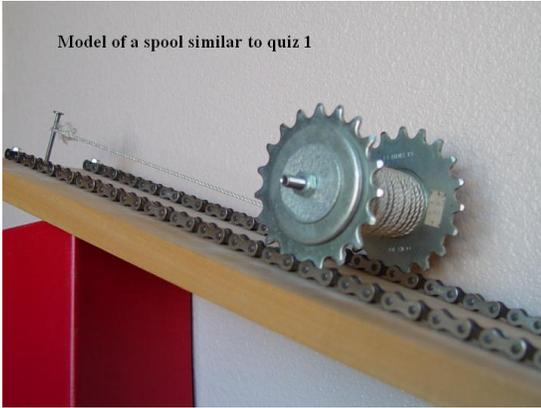
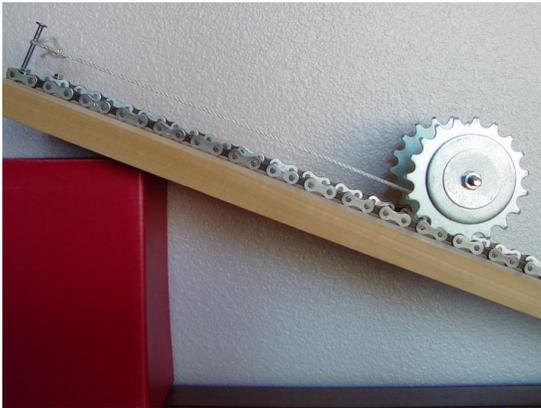
The next two photos show a model that is similar to the quiz.

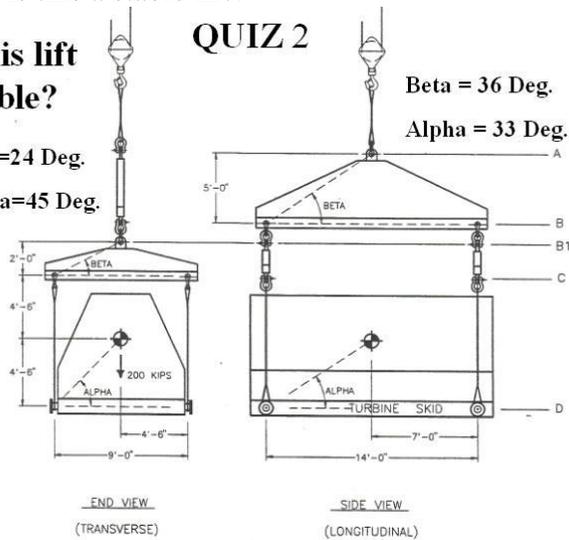
The first photo shows a turbine being lifted with four slings connected below the CG. The question is asked, is this a stable lift?

Beta = 36 Deg.

Alpha = 33 Deg.

The next two photos show that the answer is NO, this lift is not stable in the transverse direction because the angle Alpha is greater than the angle Beta and marginally stable in the longitudinal direction.

Now the most often asked question is how much greater must angle Beta be than angle Alpha. Theoretically and on paper, if Beta is as great as say one degree larger than Alpha, the lift should be stable. But due to the dynamics of lifting, the CG location not always being known accurately, the slings not always matched for length, etc, it is recommended that Beta be at least 20 degrees larger than Alpha. In most cases this will be conservative but safe.

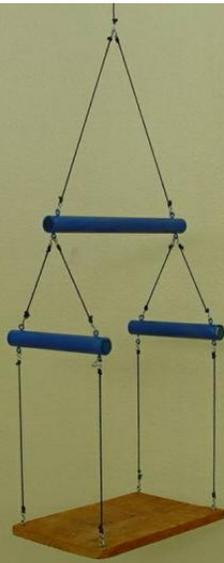
**AN EXAMPLE
SIMILAR TO
QUIZ 2**

The next photo shows a platform supported by three spreader bars, two transverse and one longitudinal.

All it took to construct this model was a piece of board, string, one inch dia. PVC, screw eyes and S hooks.

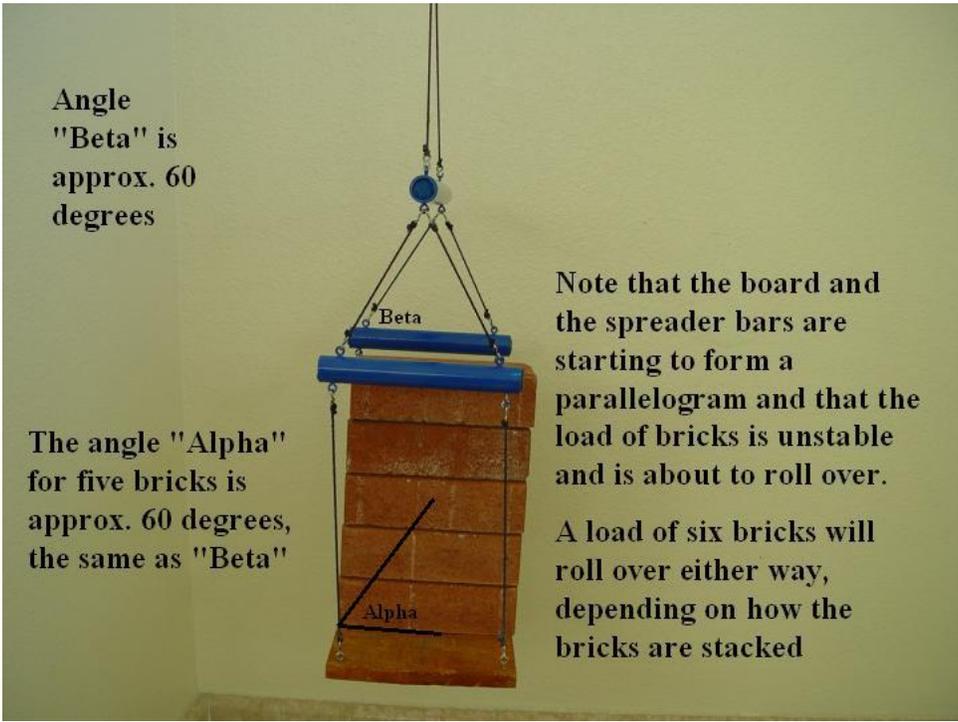
The next photo shows that when a five brick load is placed on the platform, angles alpha and beta are equal and the brick load is starting to turn over. Note the transverse spreader bars and the platform are starting to form a parallelogram. For a six brick load, the platform will turn over no matter which way the bricks are placed on it.

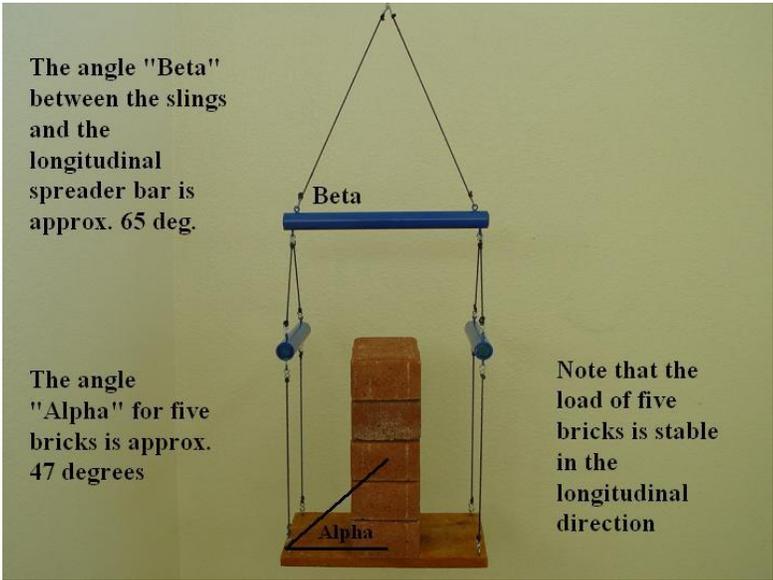
The next photo shows that a five brick load is stable in the longitudinal direction.

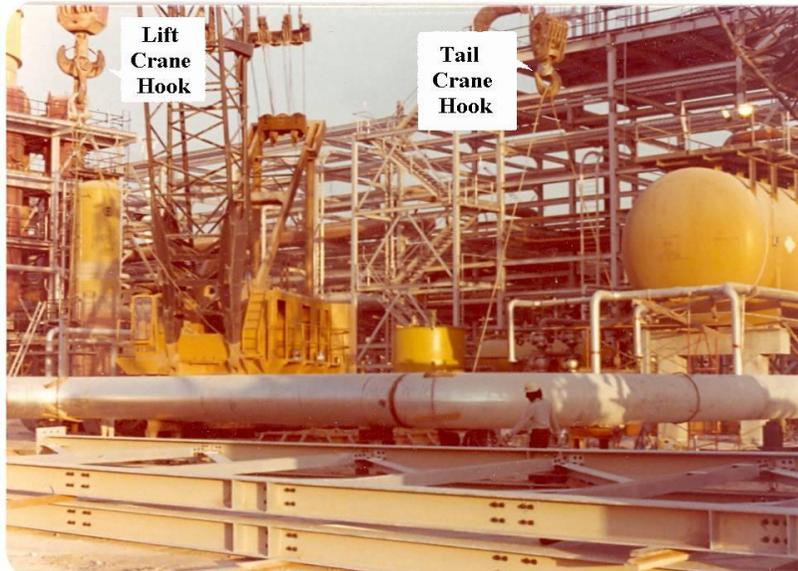
We had a pre-lift meeting before we began hooking up the rigging and I went over the lift. One of the things I pointed out was that with the pipe in the initial pick position (IPP) that the 1" diameter sling going from the hook to the end of the horizontal run would be slack on the ground. The 1" sling was located outboard from a 2" nozzle that would keep it from sliding toward the CG.

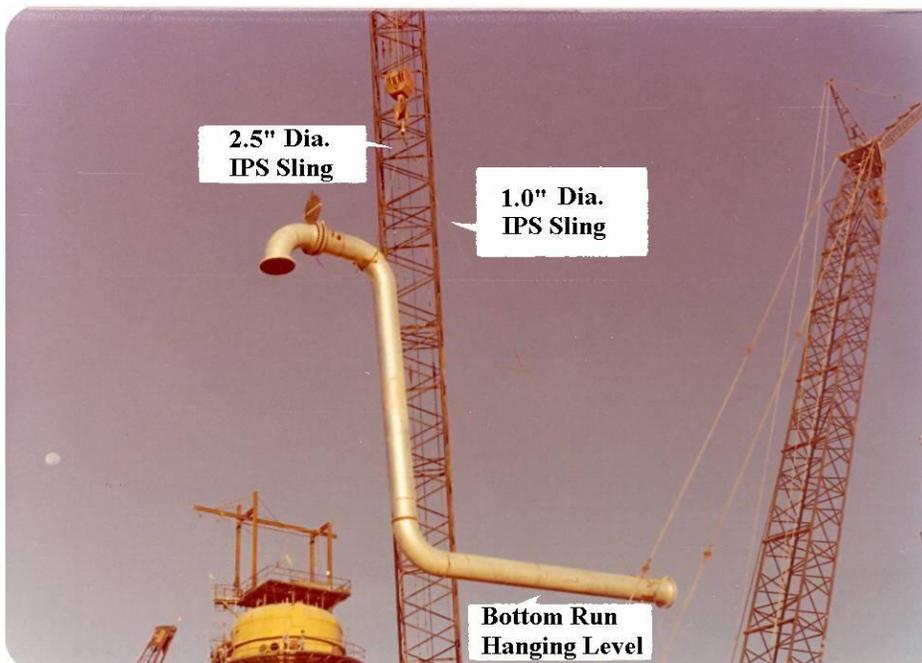
Now Johnny didn't want to lose face as there were a lot of other crews watching to see if we were going to let the overshot line fall off the pipe stands when we were floating it. He was very nervous as the up ending began as I don't think he believed me that the overshot line would lift vertical off the pipe stands and then hang level. When the overshot line was plumb with the bottom run level, you should have seen the look on Johnny's face.

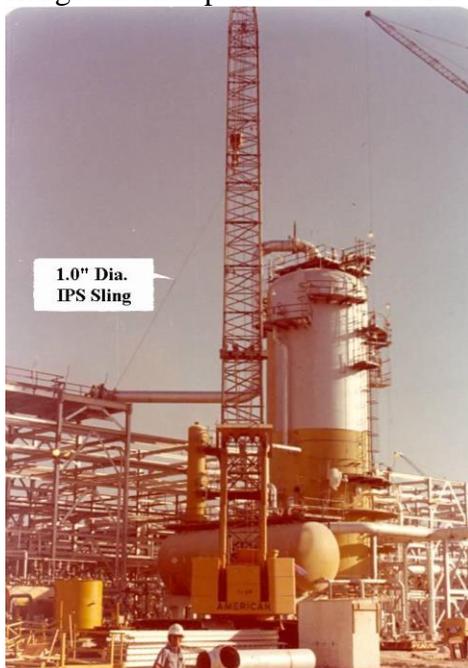
He had the crew swing the overshot line 180 degrees and set it so that the flanged end mated up to a flange on the top of a contactor and the level run rested on a saddle on top of a pipe rack.

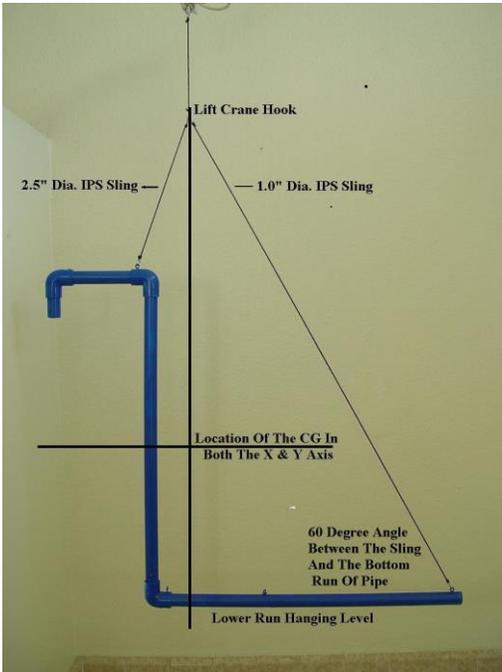
These calculations were to locate the tailing slings so the overshoot line would lift level off the pipe stands.

As soon as the overshot line was set, Johnny came down off the pipe rack at a run and grabbed me by the hand and asked “how did you know that the 1” sling would tighten up and that the overshot line would hang level?”. I asked if he really wanted to know and he said yes. So I took him to my office and showed him my calculations for the weight and location of the CG. I then showed him my layout in the vertical where I plotted the location of the CG in both the X and Y directions. I then showed him how I started at the end of the level run and ran a sling up a 60-degree angle to where it intersected the vertical line thru the CG. This would be bearing on the hook. I then ran a sling down to the 90-degree elbow because it was a good place to connect to the overshot line without the sling slipping. I then showed him how I

calculated the tension in each sling and arrived at the sling diameters. And how I took moments to see what the reactions would be when the overshoot line was laying in the horizontal.

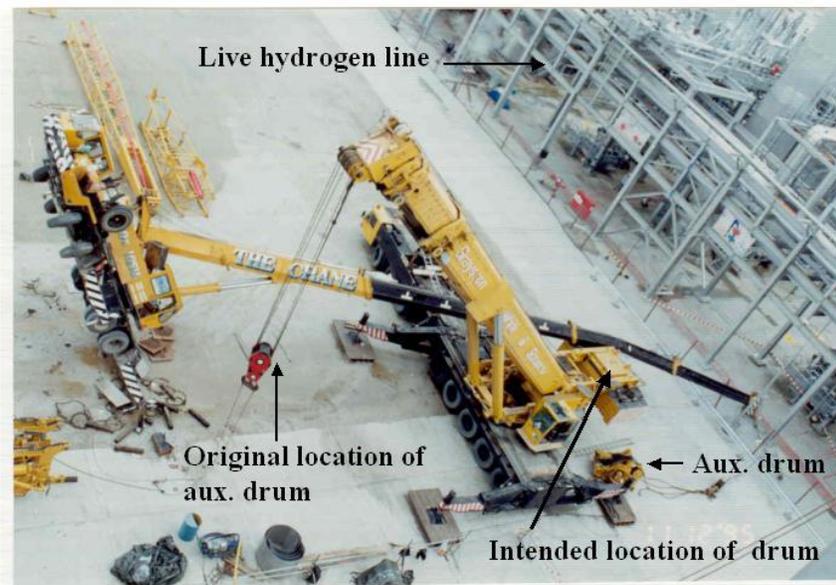
50 Te Crane turned over on 400 Te crane

This photo shows the original location of the auxiliary drum that was to be installed on the 400 Te crane, the intended location, its location after the accident and the live hydrogen line that boom missed by about a foot.

This photo shows Accident 1 and the factors that lead up to a crane accident where a 50 Te hydraulic crane was being used to install a luffing jib on a 400 Te hydraulic crane. This was the accident that brought about the Fluor Crane and Rigging Procedure.

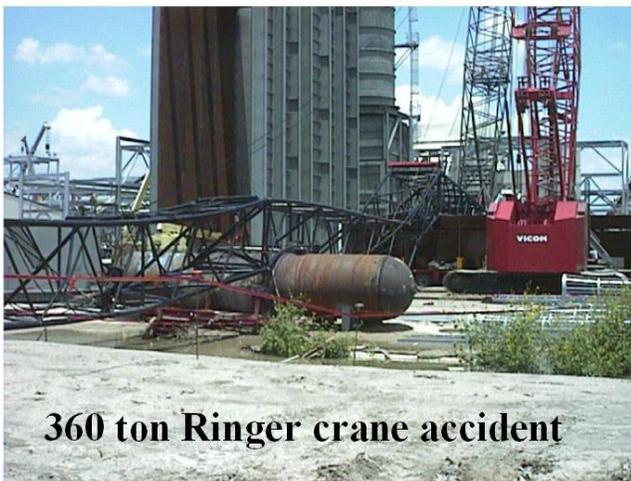
360 ton Ringer crane accident

This photo shows the boom of the LS-718 buckled on the ground and laying on top of the steam drum.

Prior to the accident, the Fluor Construction Manager for the site called me and said it had come to his attention that the contract with the HLC did not include a load test and he wanted to know what I thought he should do about it. I told him that it would probably cost the job about \$30,000 to have the HLC perform a full load test, but an alternative would be to require them to do two things. One would be to provide documentation that they had lifted a vessel of similar weight in the last six months with the same crane configuration. Two would be to have them perform a long radius load test with a load of about 50 tons. This load test would be to just test assembly of the crane. He said the first thing that they would lift was a 60-ton stream drum and that we could use that. So I figured out the radius that they would have to boom out the steam drum for 100 % of chart and then instructed them to perform a full function operational test. The field and the HLC agreed and set the load test for the next day. We received a phone call the next day that the boom of the ringer had dropped due to the boom suspension wire rope slipping out of the dead-end becket.

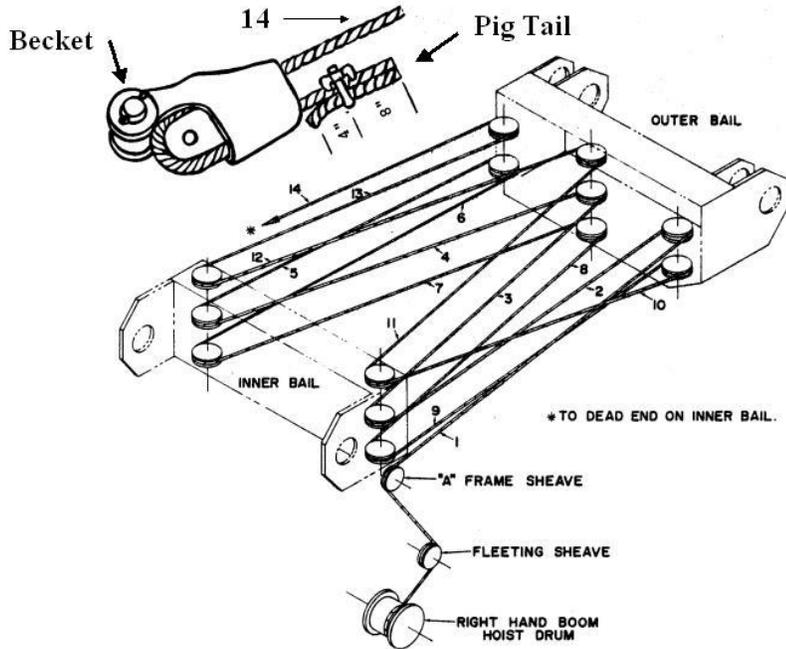
This photo shows details of the boom suspension. The accident investigation determined that the correct wedge for the becket could not be located so the HLC used another one and did not put a safety cable clamp on the pig tail of the wire rope.

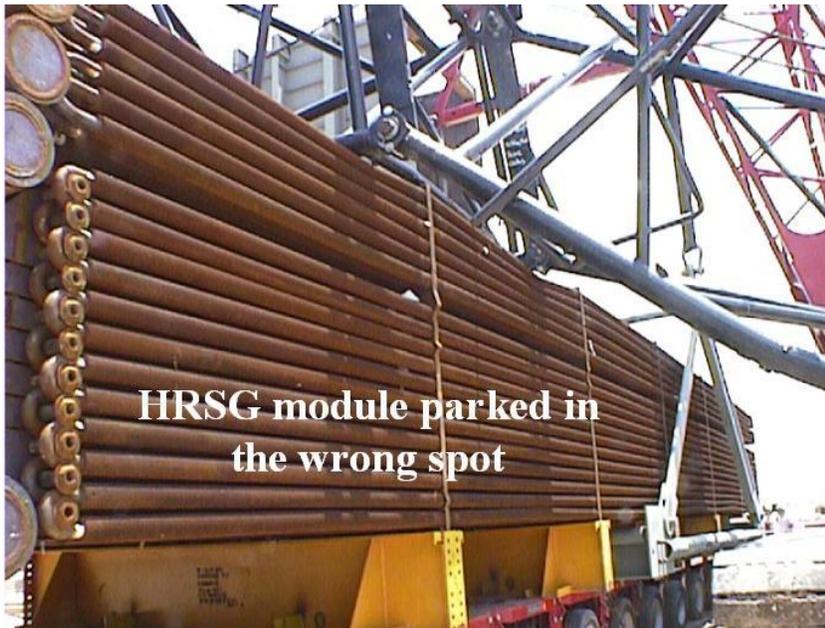
This photo shows the boom draped over an HRSG unit that had been staged to be lifted right after the load test. It is always a good idea to keep the area clear until after the load test.

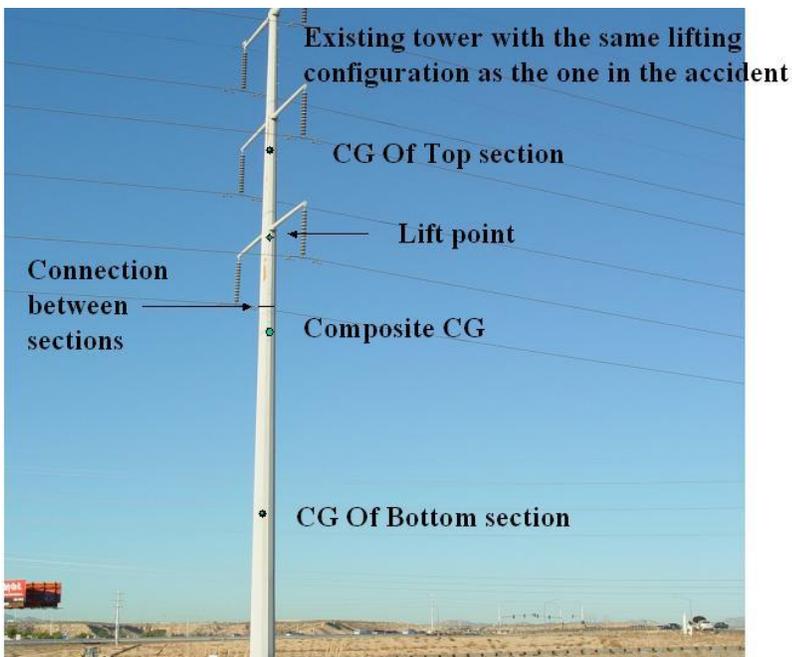
This photo shows an existing tower with the same configuration as in the accident.

1. A 125 ton truck crane was lifting a two section electrical transmission tower. The pick point was just above the connection
2. Just as it was upended, the the bottom section fell off, moving the location of the CG above the lift point
3. The top section did a 180 degree loop and twisted the boom off the crane. No one was injured
4. CONTRIBUTING FACTORS:
 - a) The rigging crew relied on a pressed fit and friction to hold the two sections together.
 - b) The sections should have been welded or bolted together

This photo shows the bottom half of the tower laying on the ground and the top half laying on the crane and boom. As the tower was almost in the vertical, the bottom half slipped out of the top half, resulting in the CG suddenly being above the lifting point. The top section did a 180-degree loop and twisted off the boom. Luckily, no one was hurt. This crane was on rental to the contractor constructing the towers, so he

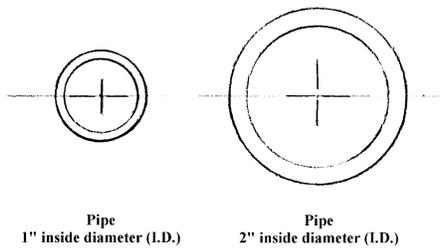
The sketch below:

Remember, the formula for the area of a pipe is:

$A = \text{PI} * r^2$
 = 3.14 times the radius squared

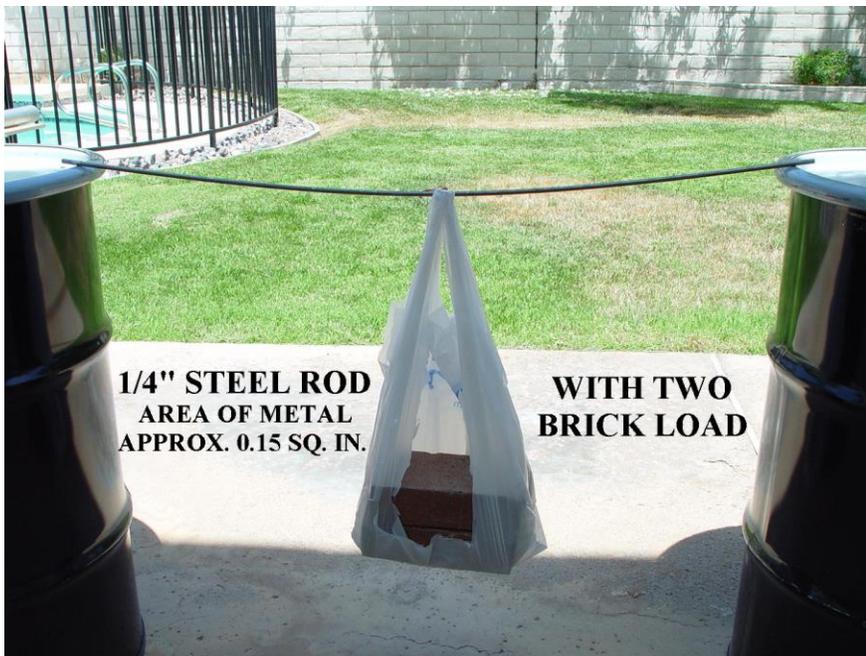
The next photo shows the 1/4 " rod suspended between two barrels with a two brick load. Note that it has a large deflection, very near the yield point.

Demonstrate which has the greatest strength as a beam, a 0.25" diameter solid rod or a 1" diameter pipe (a piece of conduit) where they both have approximately the same cross-sectional area of metal ie, 0.15 sq. inches.

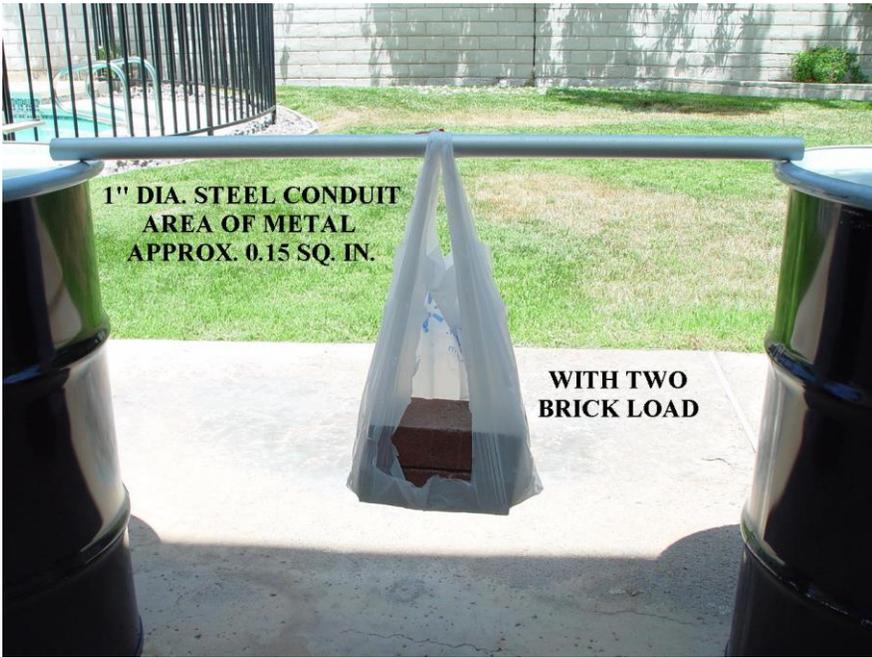
The next photo shows the 1" conduit with the same load and zero deflection.

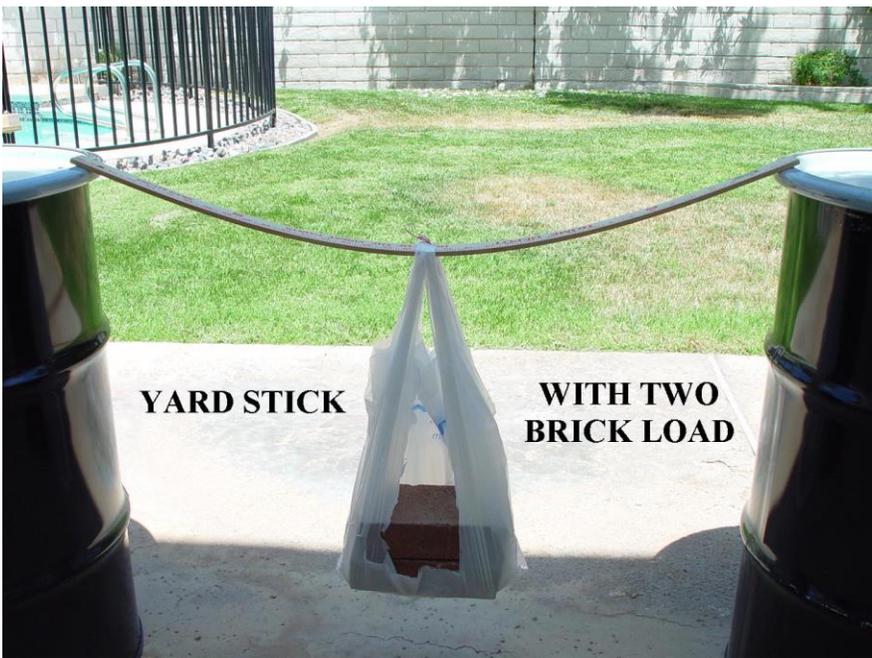
The next photo shows a yard stick suspended between two barrels with a two brick load. Note that the yardstick has massive deflection, again very near the yield point.

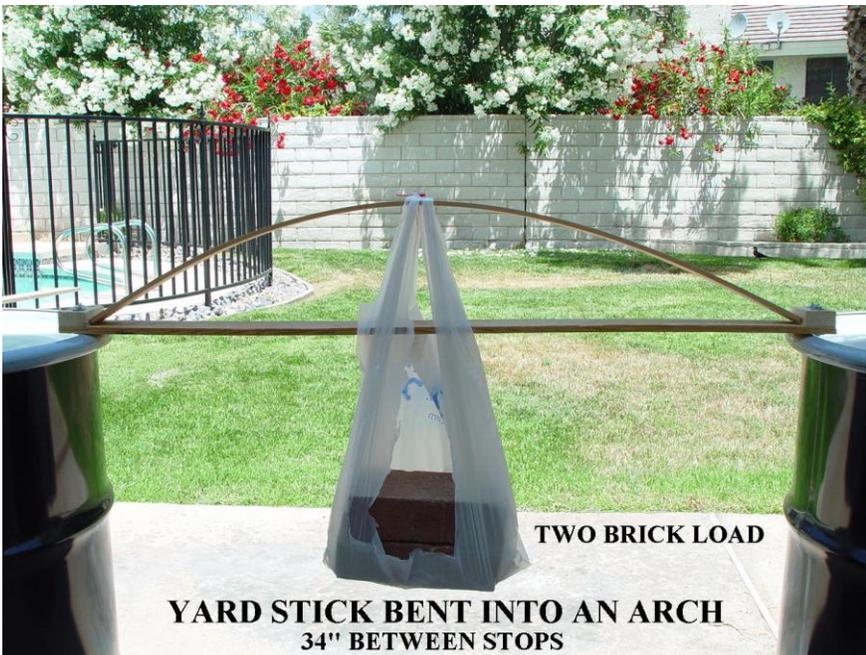
The last photo shows a yard stick bent into an arch. Note that for a two brick load, that there is zero deflection. Also note that the horizontal member is thru the sack but is not carrying any load. The rooster could have used this configuration on his bridge across the stream.
