MAXIMUM REACH ENTERPRISES

DESIGN OF JACKING POCKETS & A 1,600 TON JACKING SYSTEM FOR LEVELING A RECIRCULATION BIN

VERDE GOLD MINE, CHILE

Leveling of the recirculation ore bin

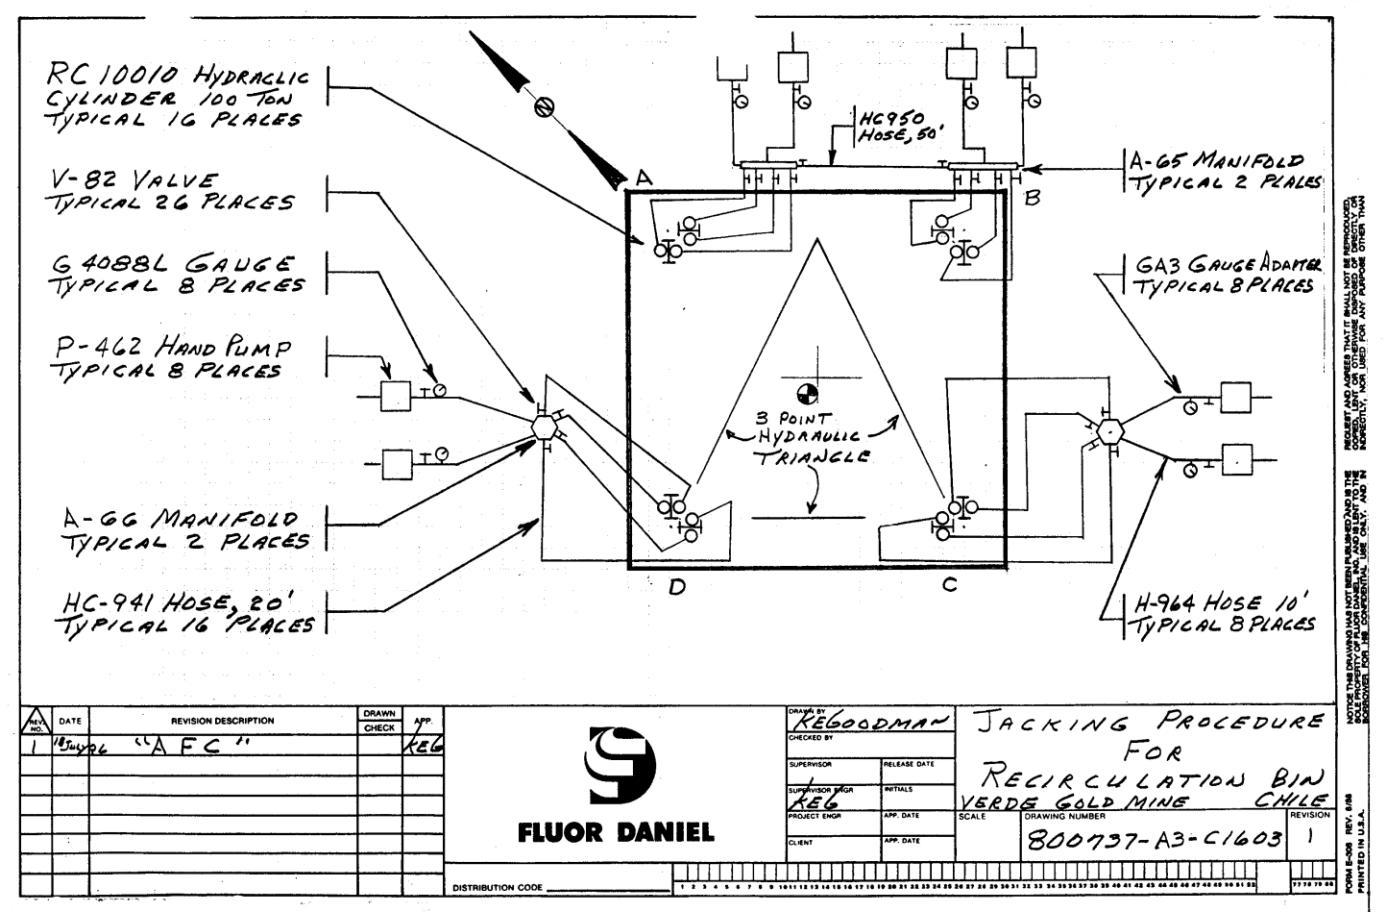
- 1. That the four cylinders at each corner are one hydraulic support point as the oil is free to equalize between the cylinders when all four V-82 valves are open that connect to the manifolds.
- 2. If the two V-82 valves located at the end of the 50' HC 950 hose are closed, then the whole system is in a four point hydraulic support system.
- 3. If the two V-82 valves at the end of the 50' HC 950 hose are open, then the

jacking system is in a three point hydraulic support system with corner C as one point, corner D as one point and corners A & B as one point. The location of the hydraulic point for corners A & B is half way between them so that a triangle is formed as shown on the schematic.

4. As an electric pumping unit wired for 220 volts was not available on short notice, two hand pumps were used at each corner, for a total of 8 hand pumps. Special precautions had to be taken to make sure that the hand pumps always had enough oil in their reservoirs.

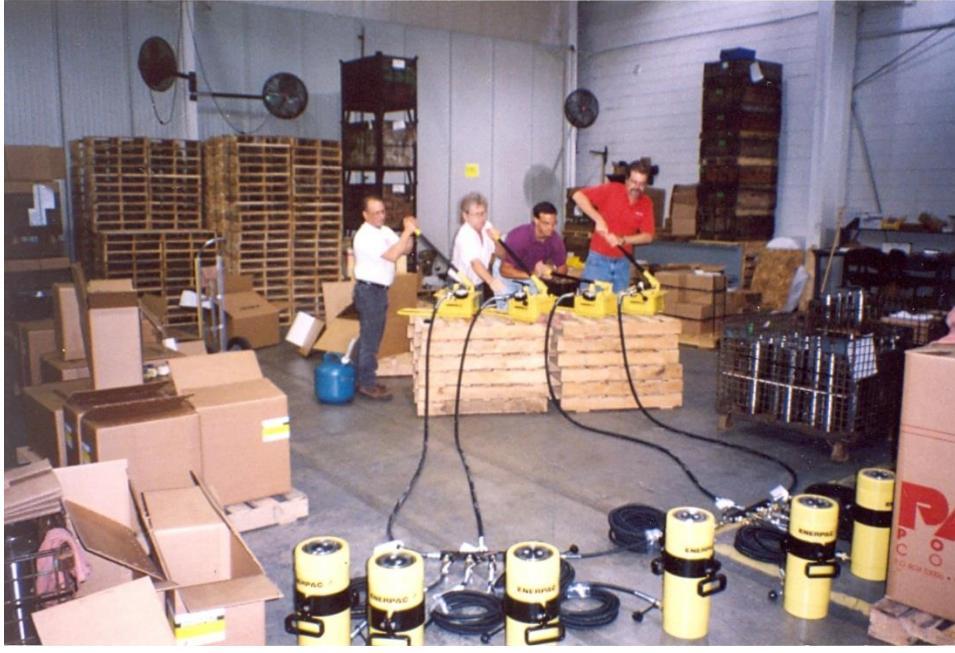
Load Testing Two 400 Ton Jacking Systems

Below are photos of the jacking system being load tested by Enerpac personnel. As most of them had never been involved in assembling and load testing their own product, they were very excited to be doing so.
